08/24/2019 – EIM retrofit on 2000 SeaRay 190BR

EIM replacement system from Flounder Pounder Marine www.fpmarine.com

Part Number: SR-panel-EIM-BR Description: EIMRS 1718631 replacement System

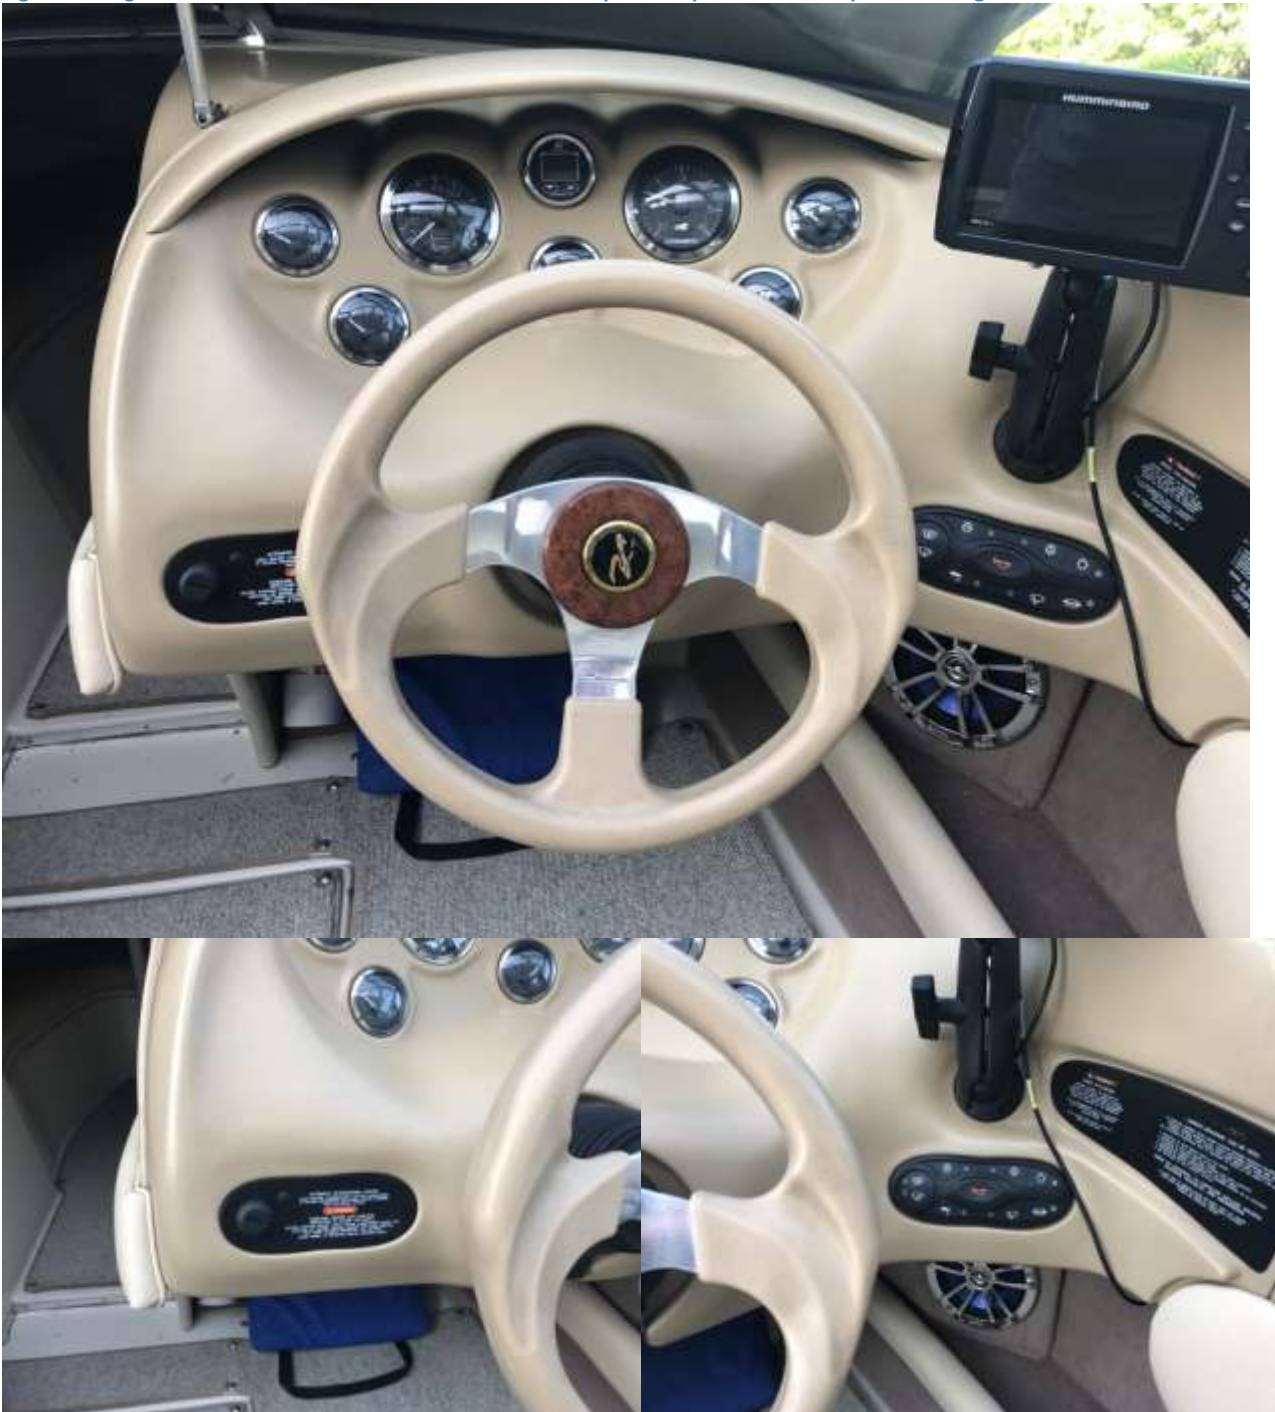
I purchased this kit because I was having intermittent issues with my main peanut pad.

Figure 1: Original dash view before installation. With close-up of two pads that are replaced during install

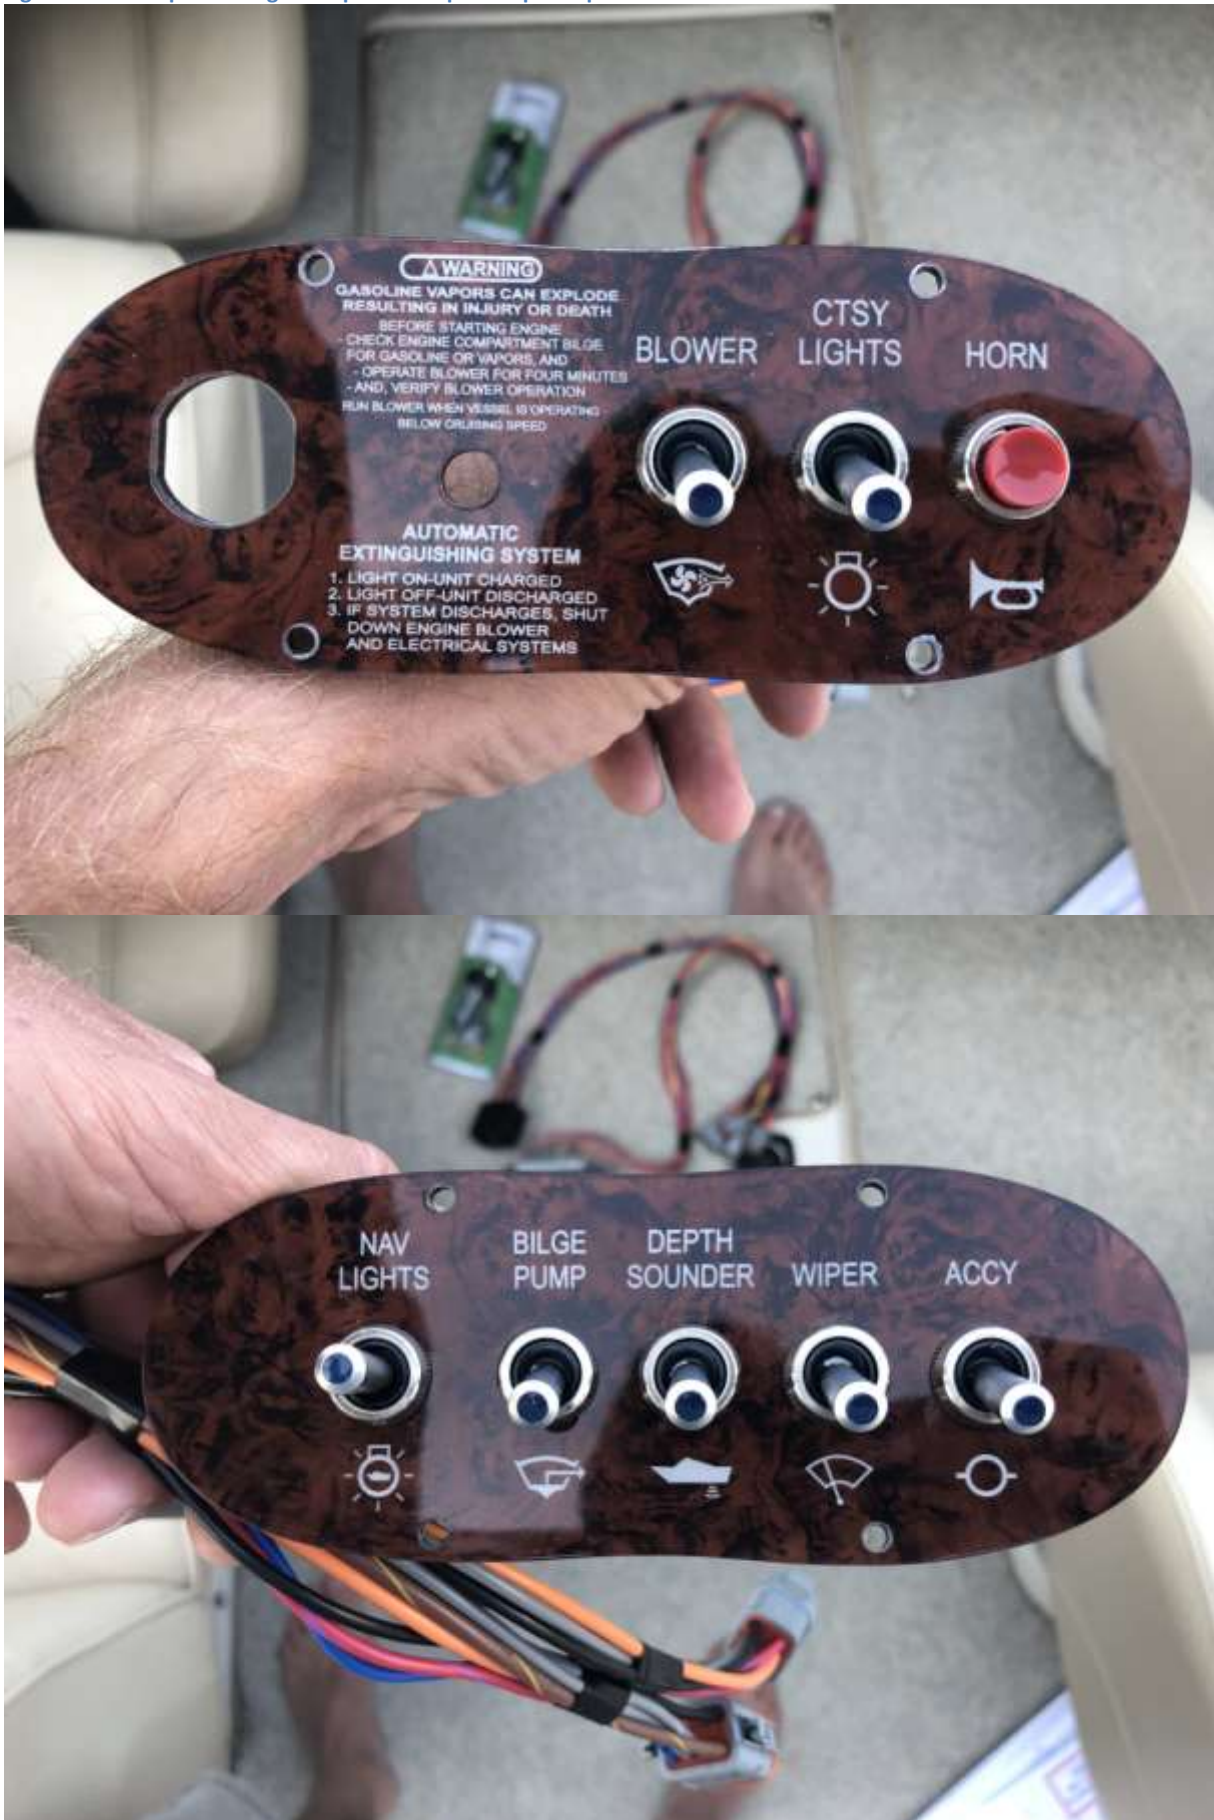
Figure 4: Close-up of new ignition panel and peanut pad replacement.

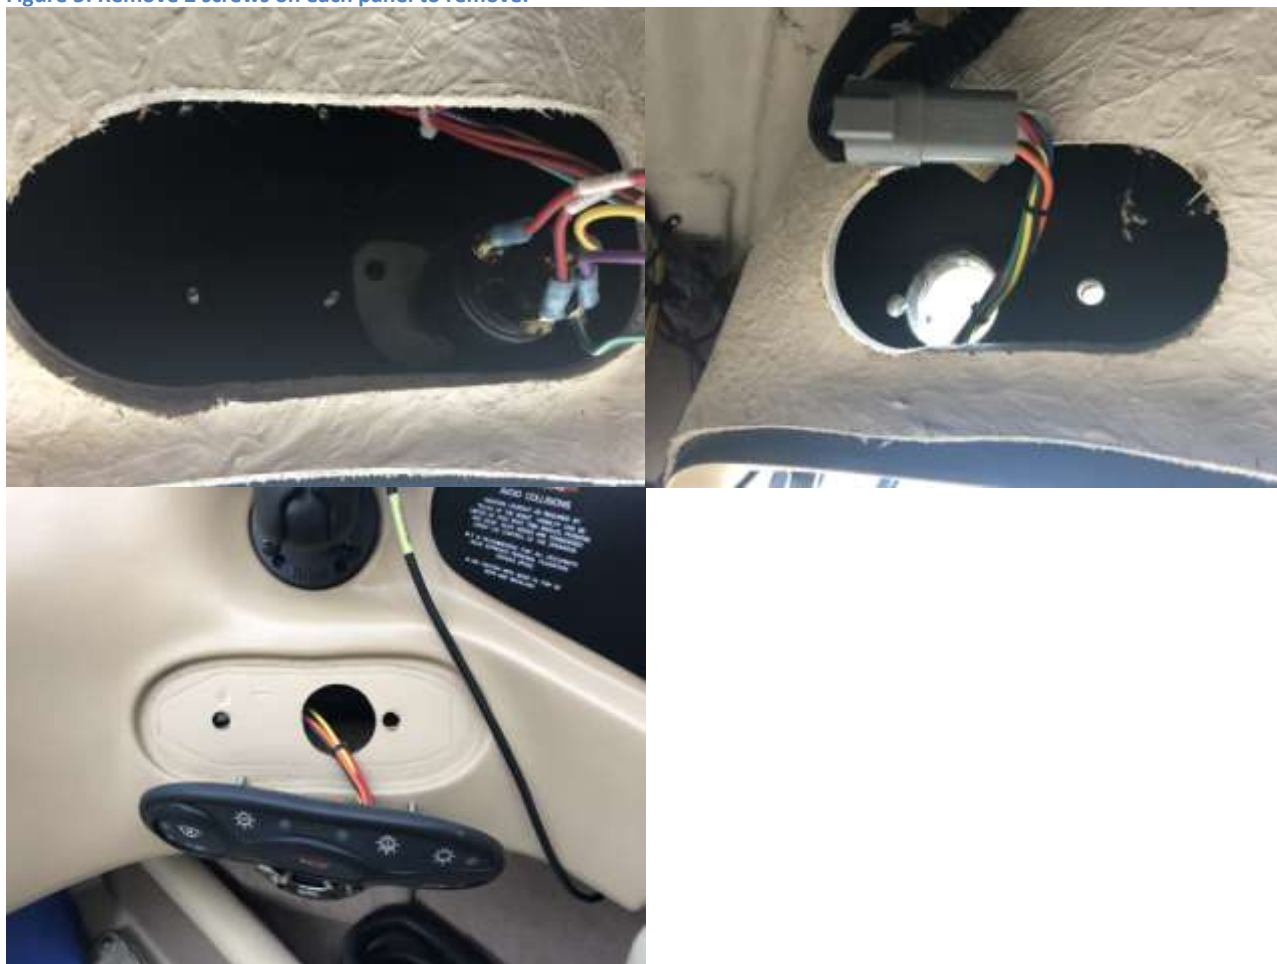
Figure 5: Remove 2 screws on each panel to remove.

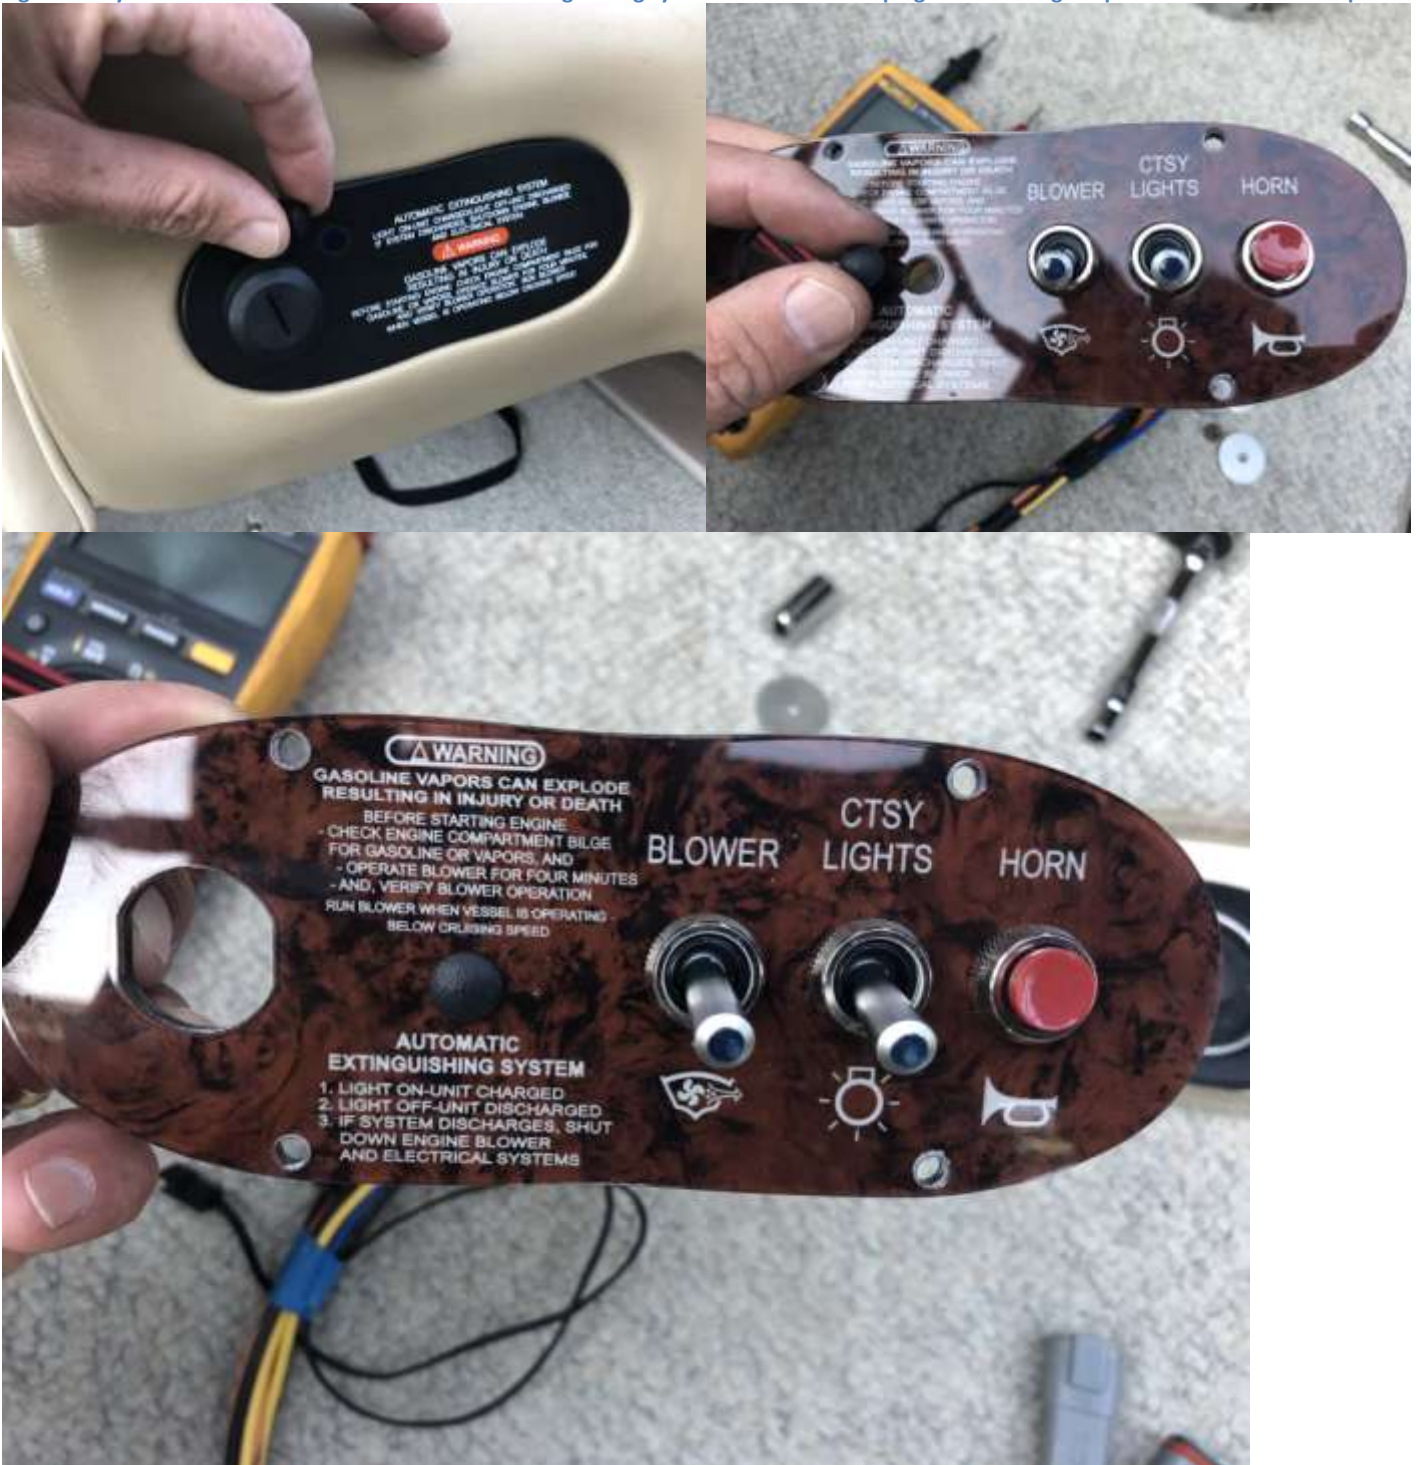
Figure 6: My install did not have the automatic fire extinguishing system. Remove small plug from the original panel and install in new panel.

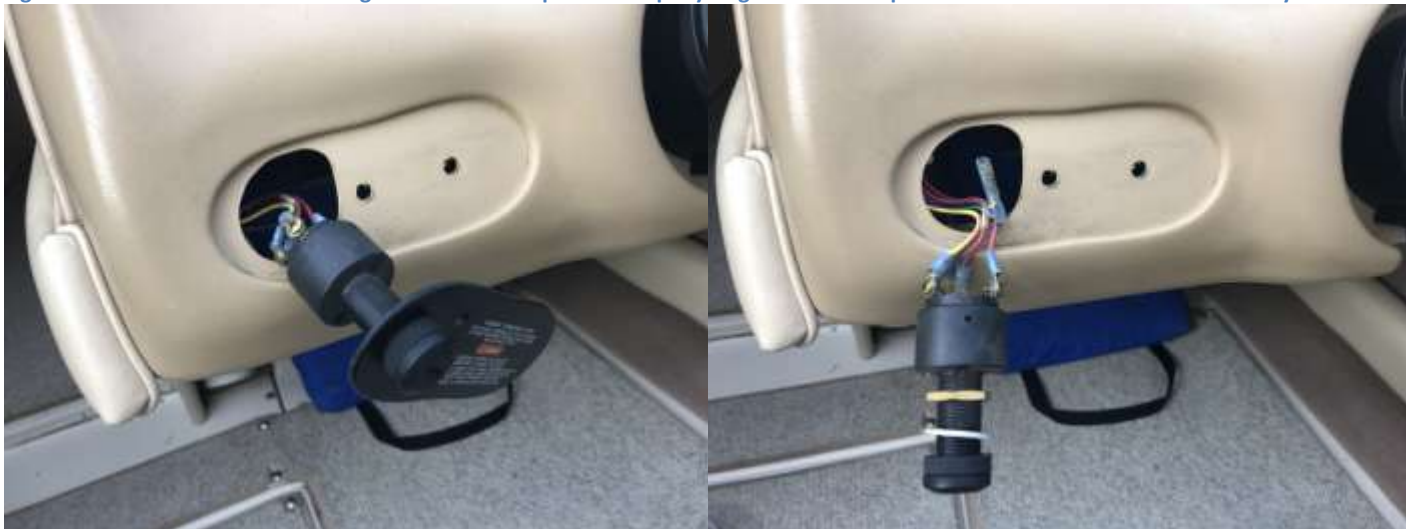
Figure 7: The kit comes with a new ignition switch. I opted to keep my original. Remove panel and leave wired to cable assembly.

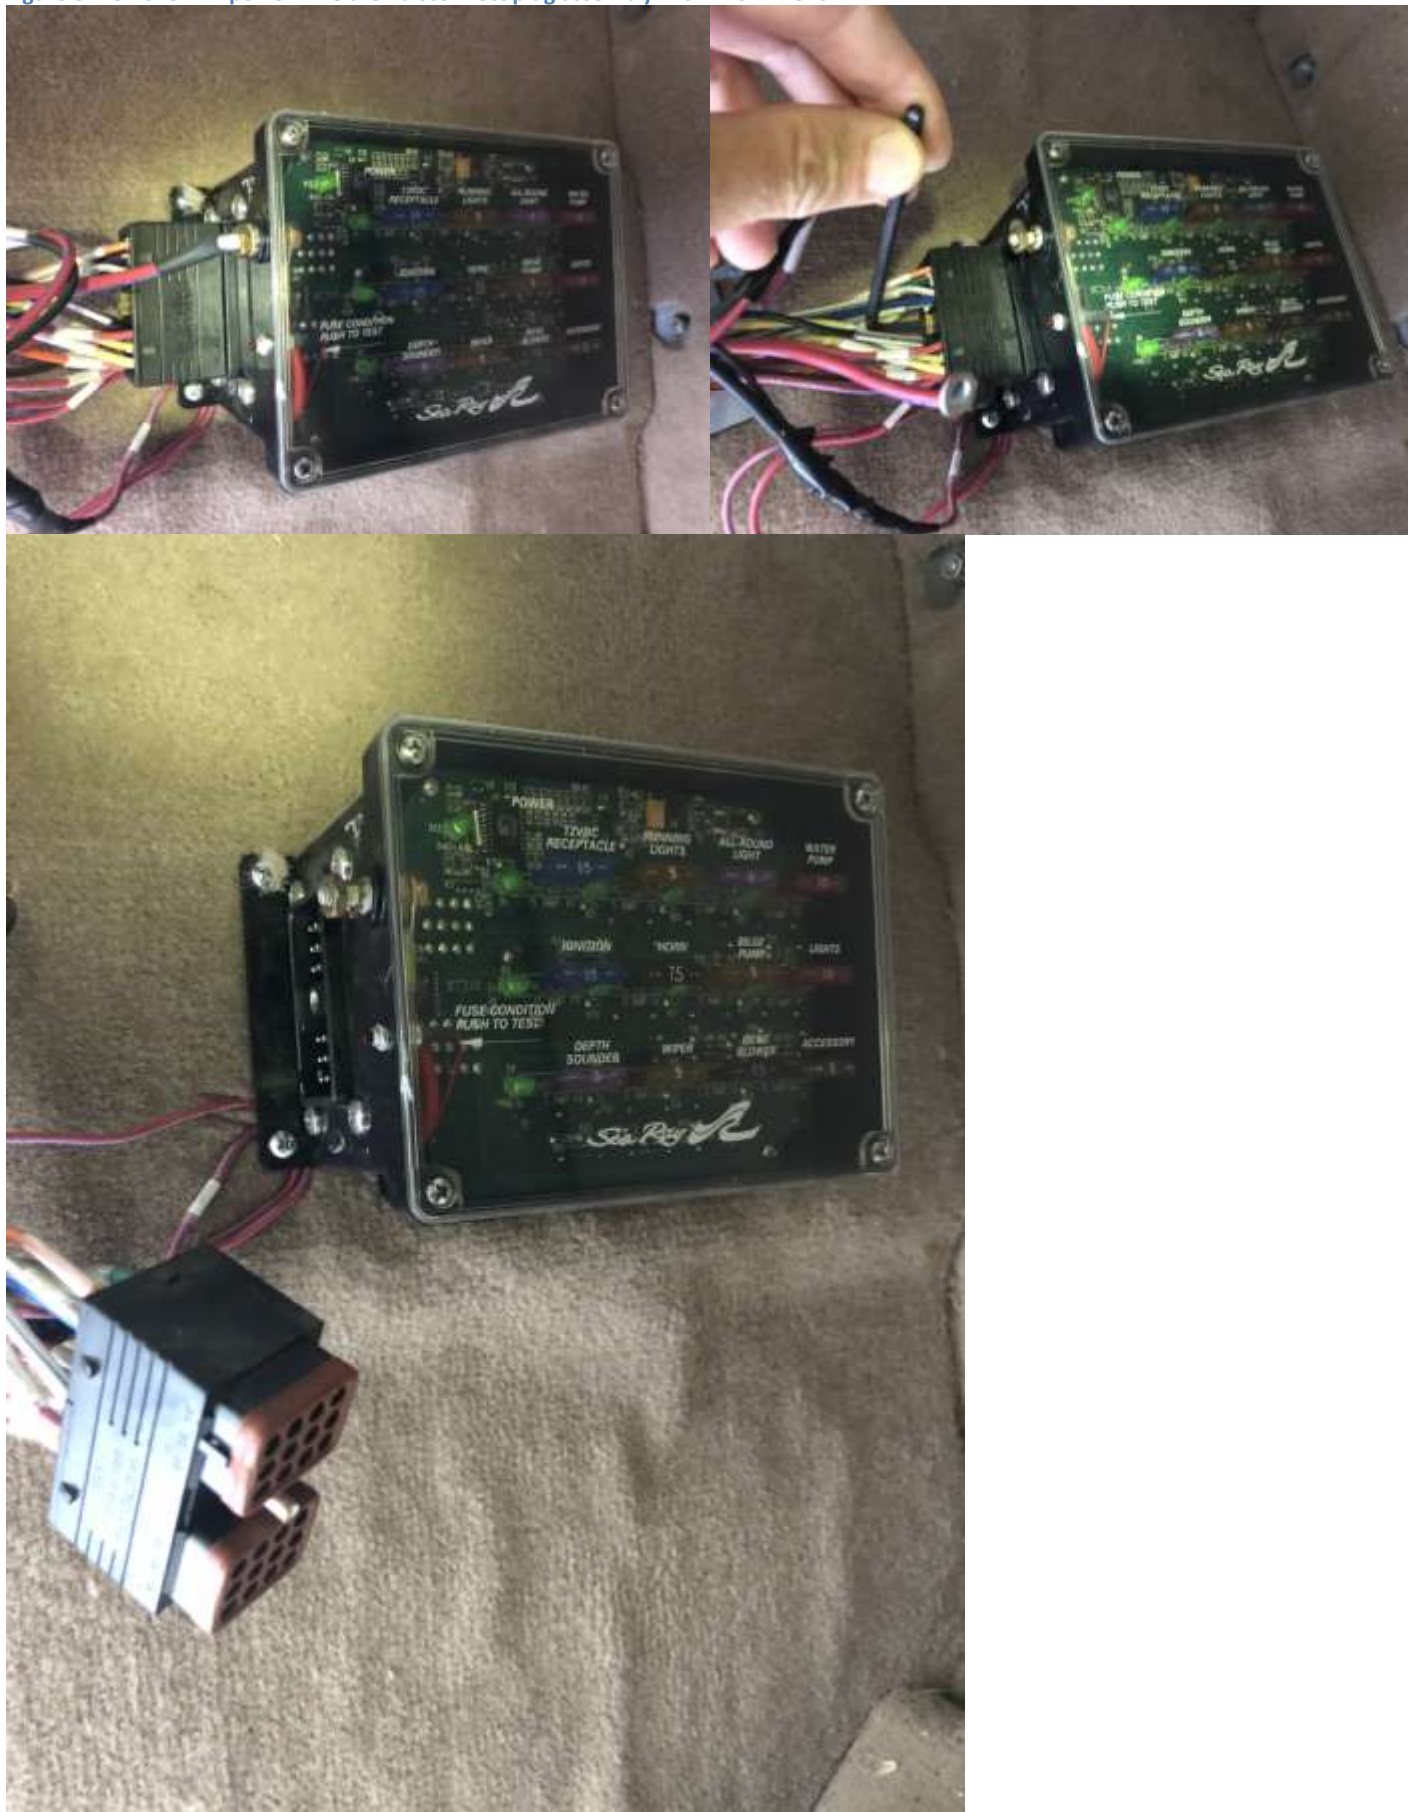
Figure 8: Remove EIM power wire then disconnect plug assembly with Allen wrench.

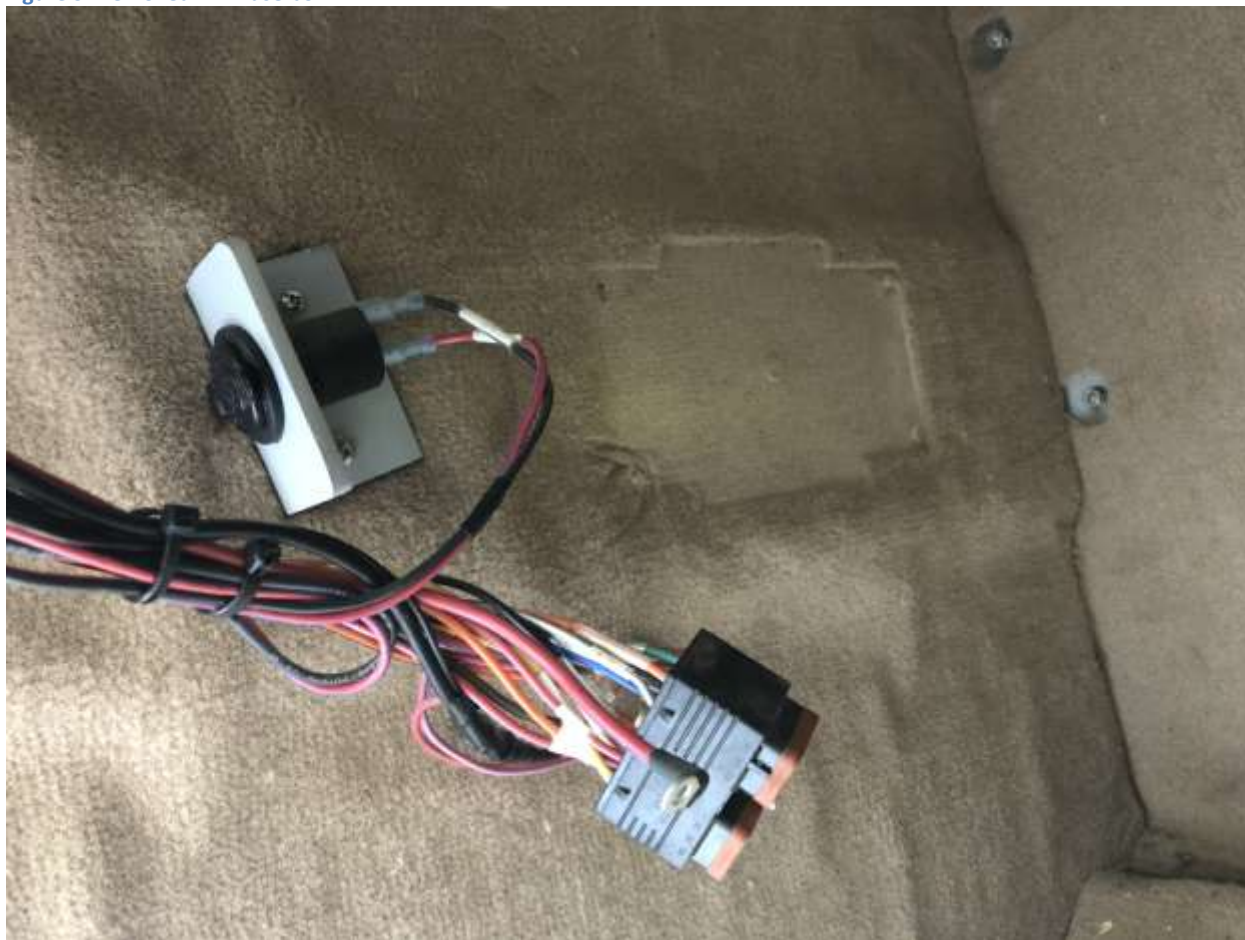
Figure 9: Removed EIM fuse box.

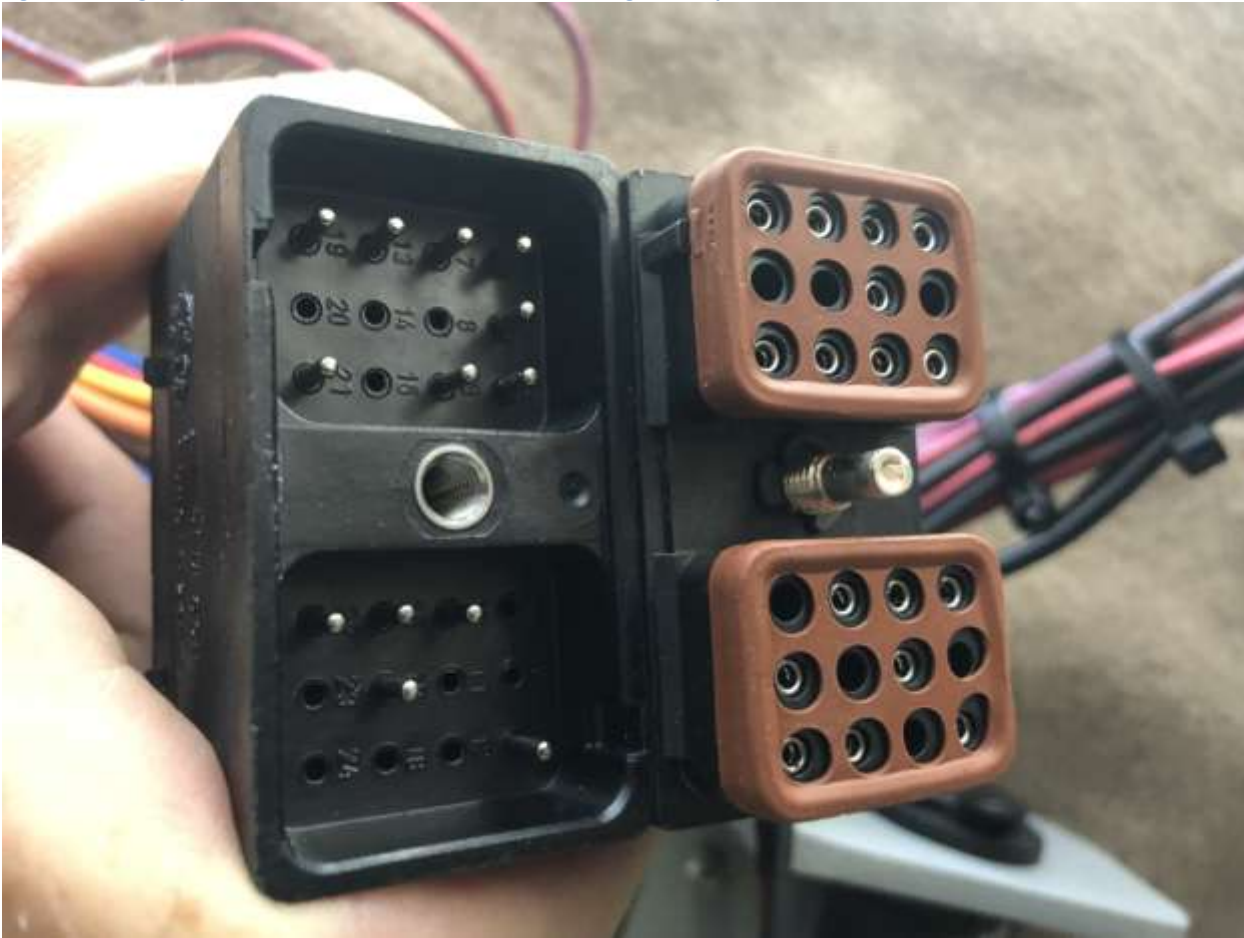
Figure 10: Plug key did not match as stated in instructions. Plug side requires modification.

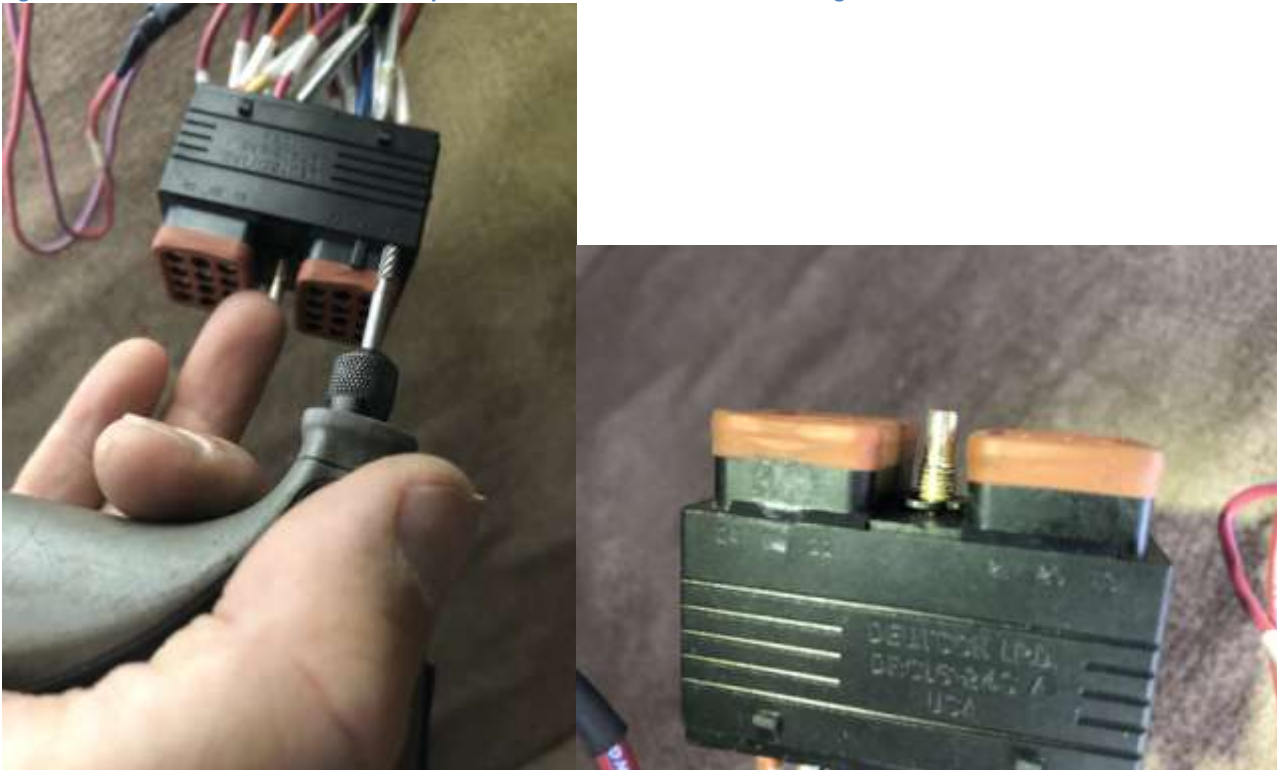
Figure 11: Used Dremel to remove mate key. Note: there is one on each terminal lug.

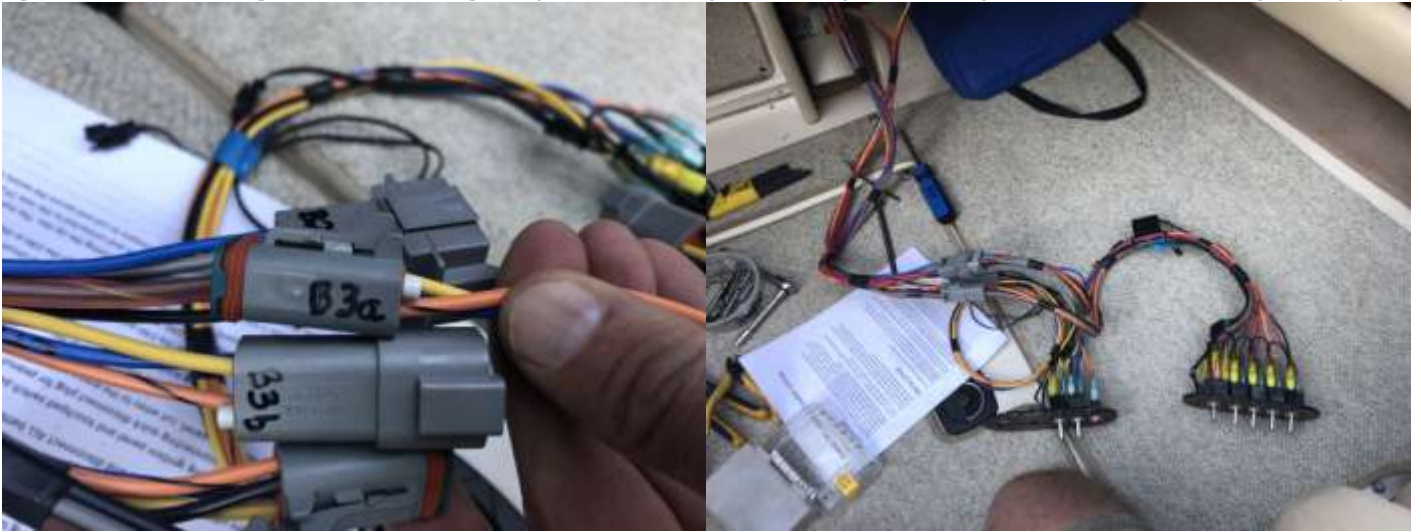
Figure 12: Before installing new EIM and cutting dash panel. I hooked up the entire system to verify correct function. Worked perfectly.

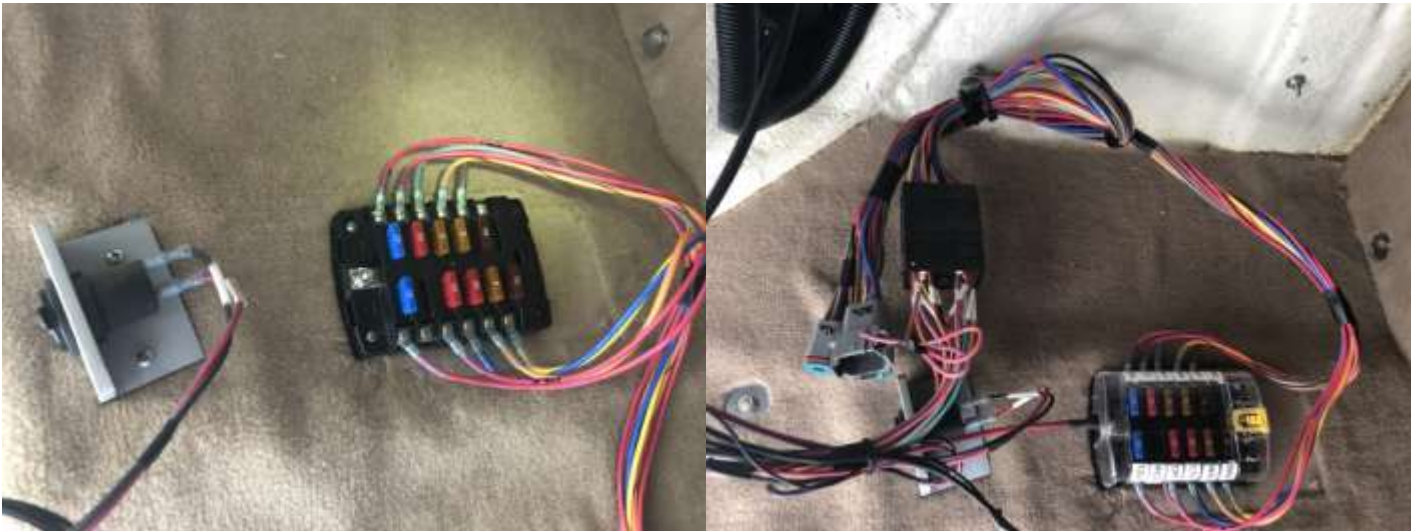
Figure 13: Installed new fuse block in same location as the original EIM, reusing the screws from the EIM removal. Installed cable hanger on available bolt and routed cable assembly over top of fuse block.

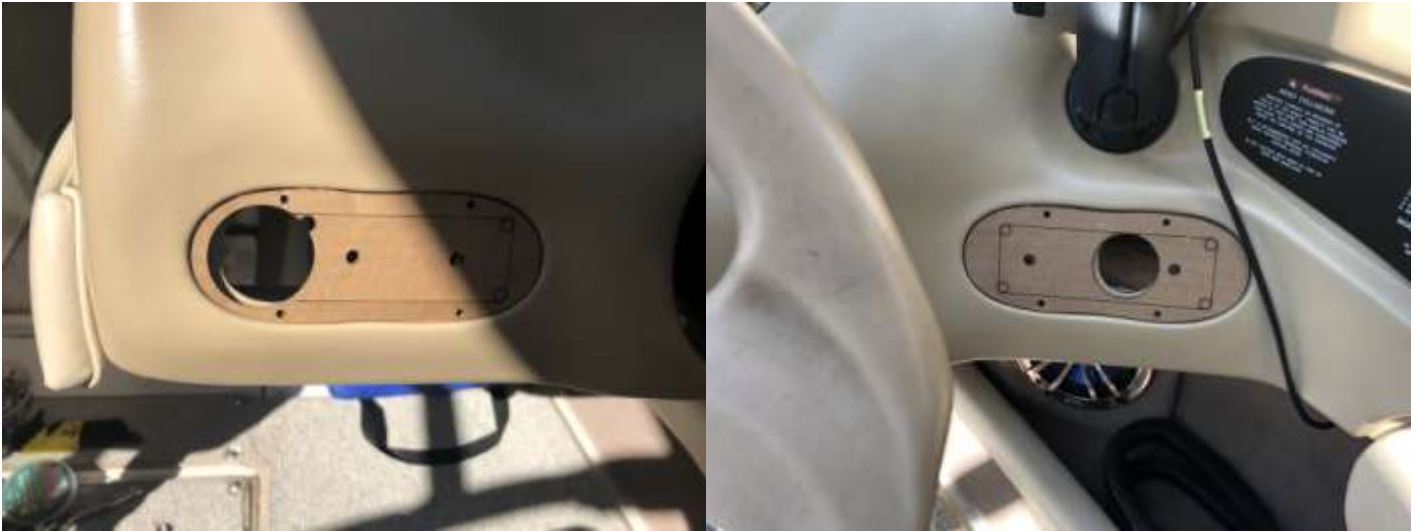
Figure 14: Installed drill/cut templates into dash panel.

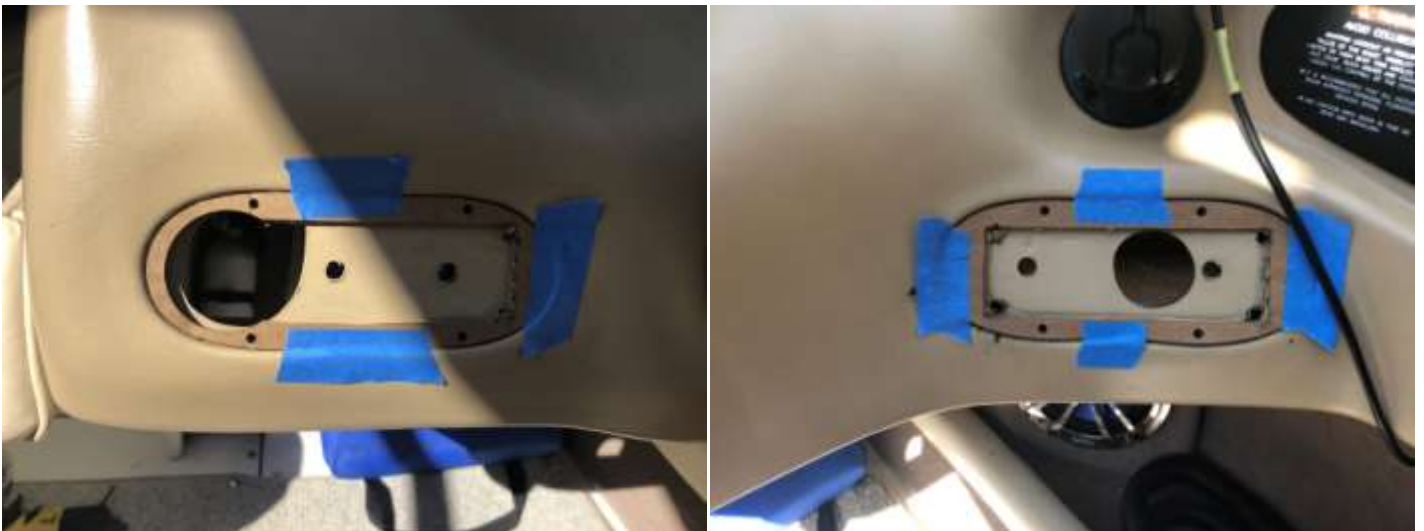
Figure 15: After drilling all the holes I removed the rectangular cut out center of the template. I did this to make cutting the opening easier.

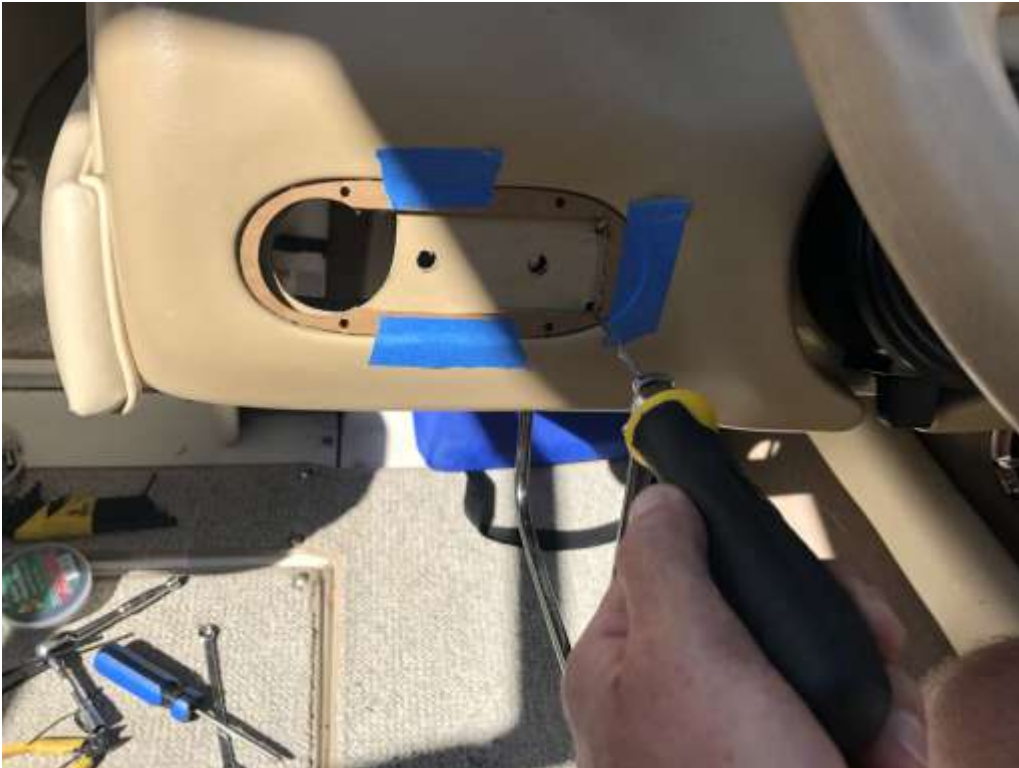
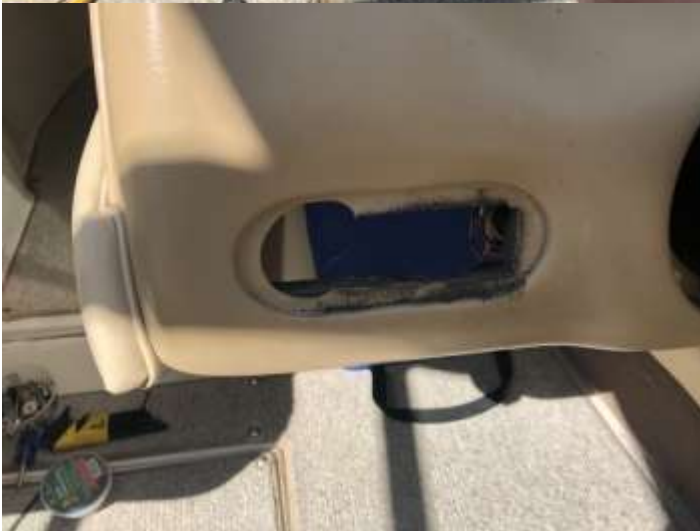
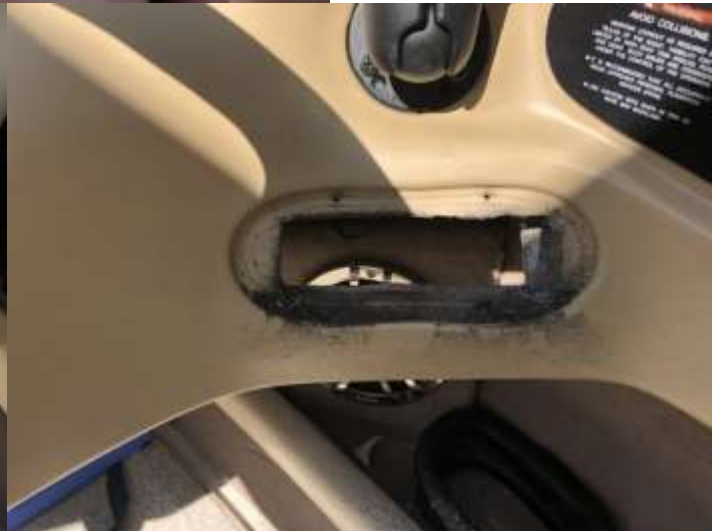
Figure 16: Used coping saw to cut slots. Worked perfectly! I am sure there are other methods, this one worked for me. The main peanut panel required cutting some of the fiberglass behind the dash panel. This just required drilling through the dash and rear fiberglass when drilling the holes. The coping saw cut both at the same time.

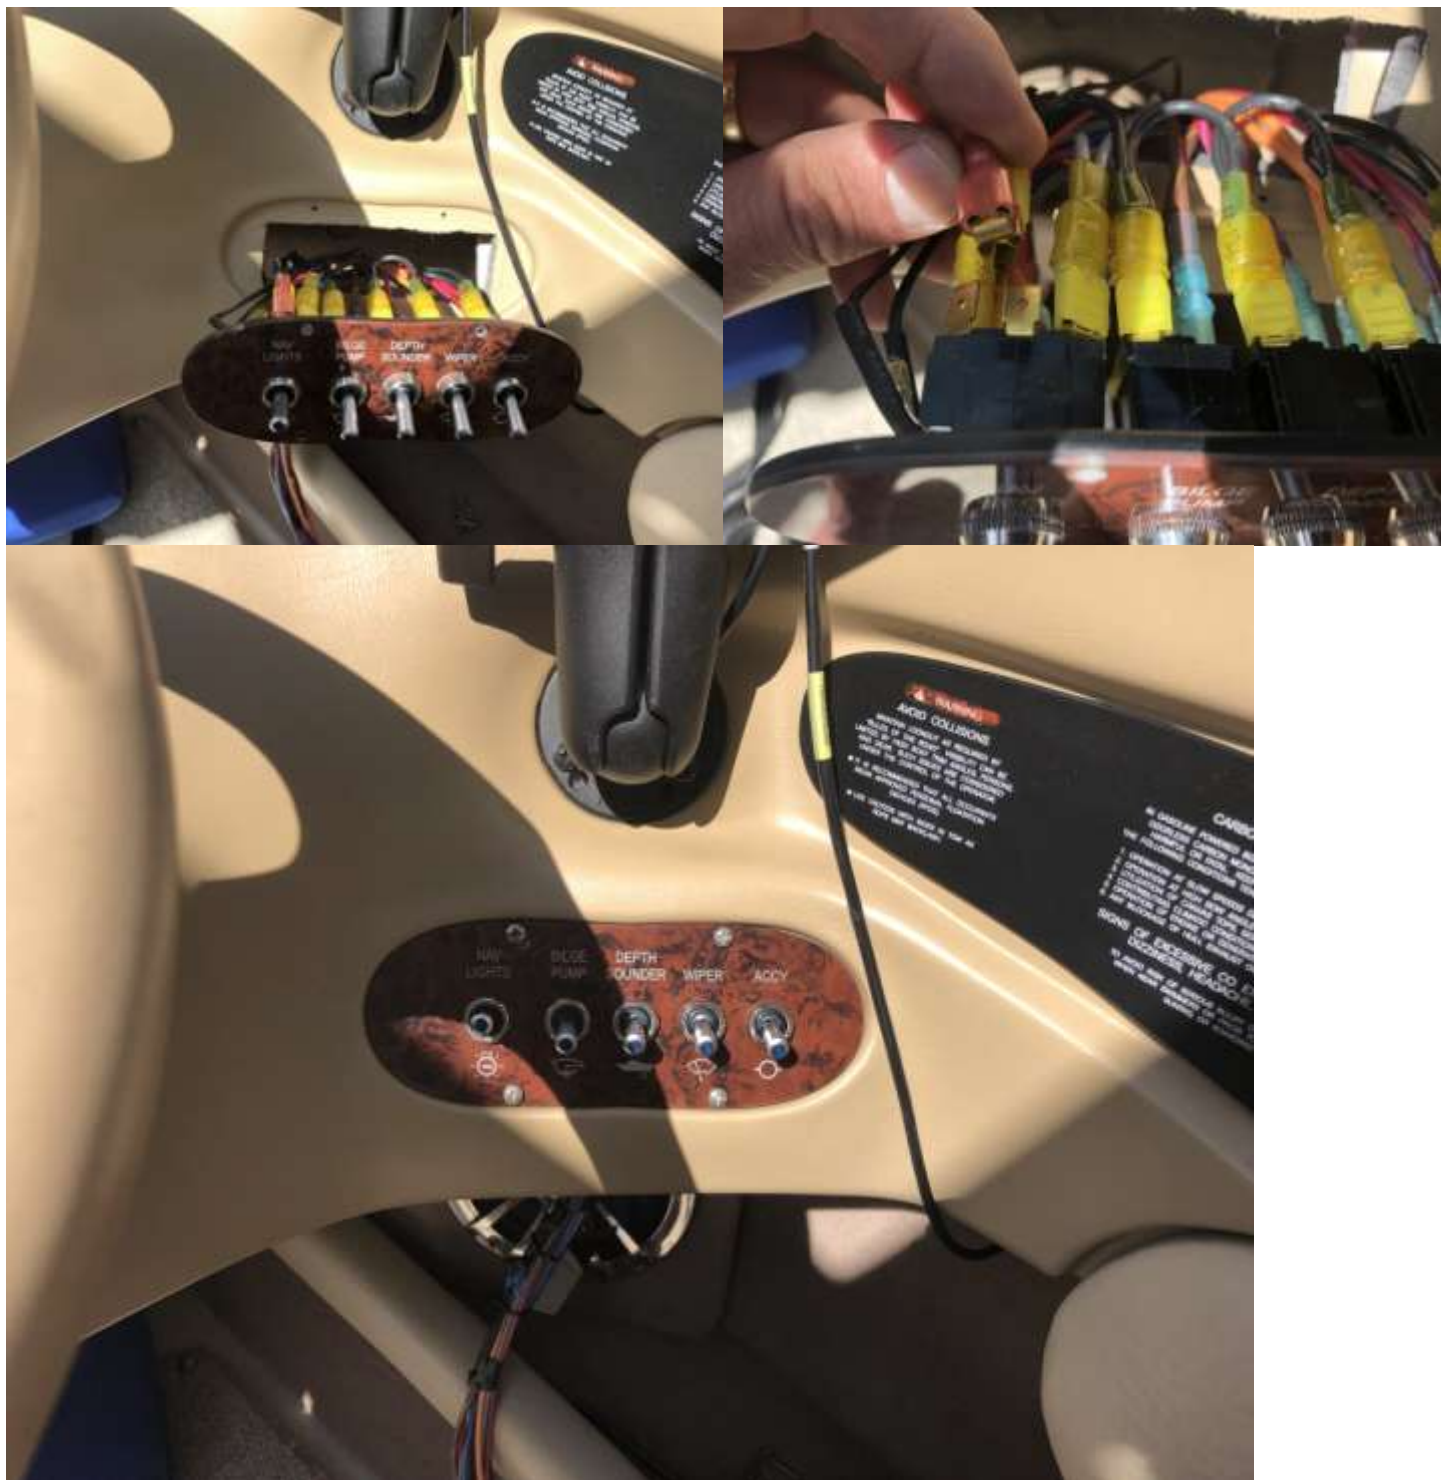
Figure 17: When installing the main switch panel, it was necessary to disconnect one terminal to fit through the cutout due to a slight interference. Remember to reconnect once the panel is installed.

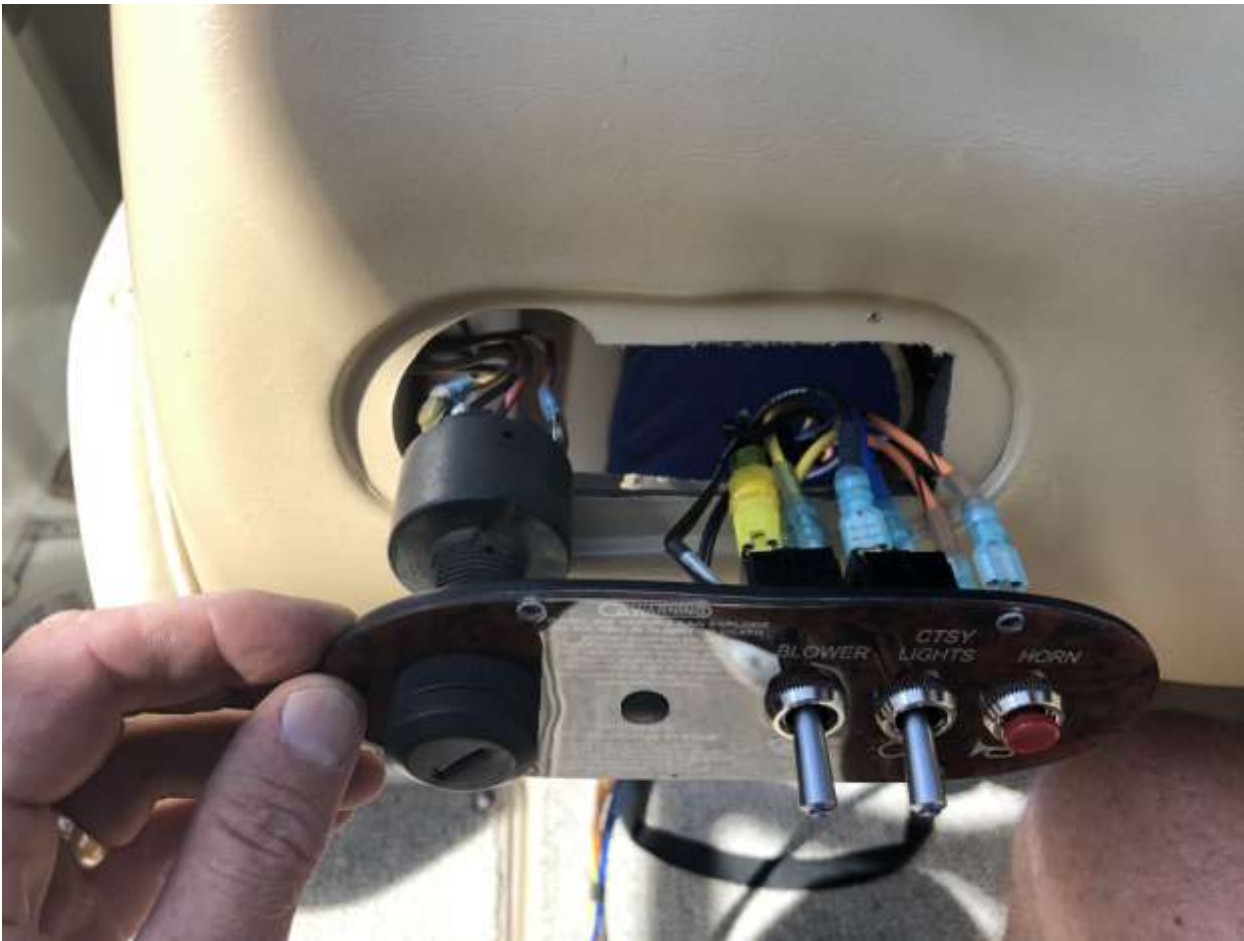
Figure 18: Install the ignition switch on new panel before installing.

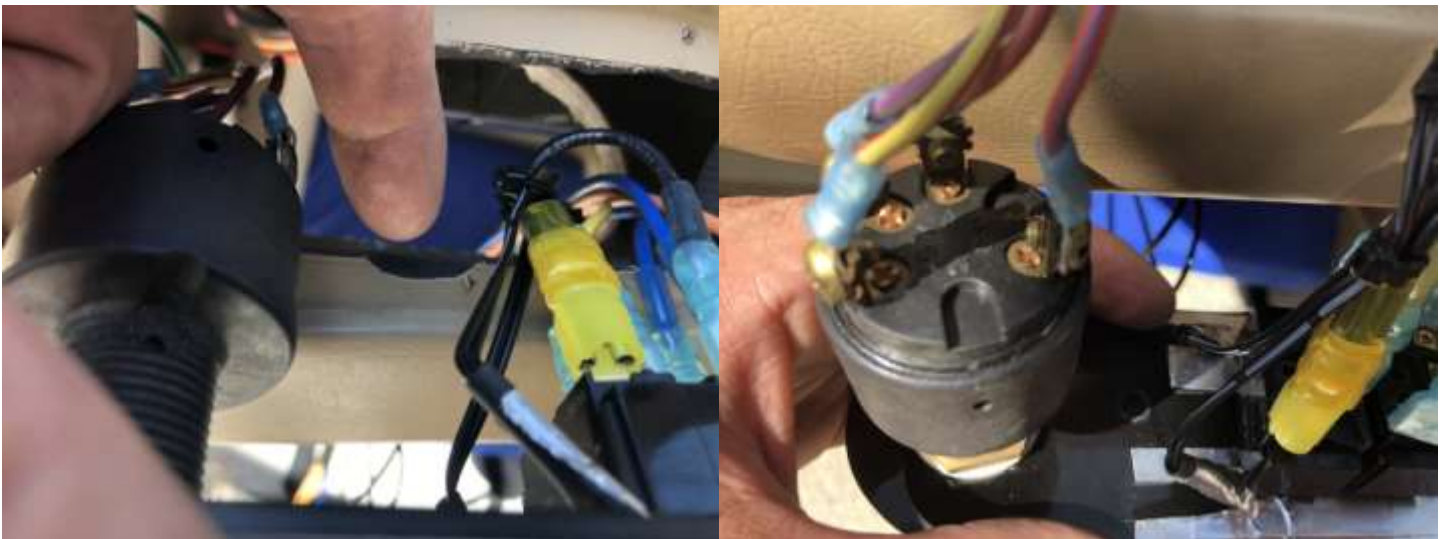
Figure 19: A small relief was needed to get the ignition panel to sit flat and flush. The wire interfering is seen in the second picture.
