08/24/2019 – EIM retrofit on 2000 SeaRay 190BR

EIM replacement system from Flounder Pounder Marine www.fpmarine.com

Part Number: SR-panel-EIM-BR Description: EIMRS 1718631 replacement System

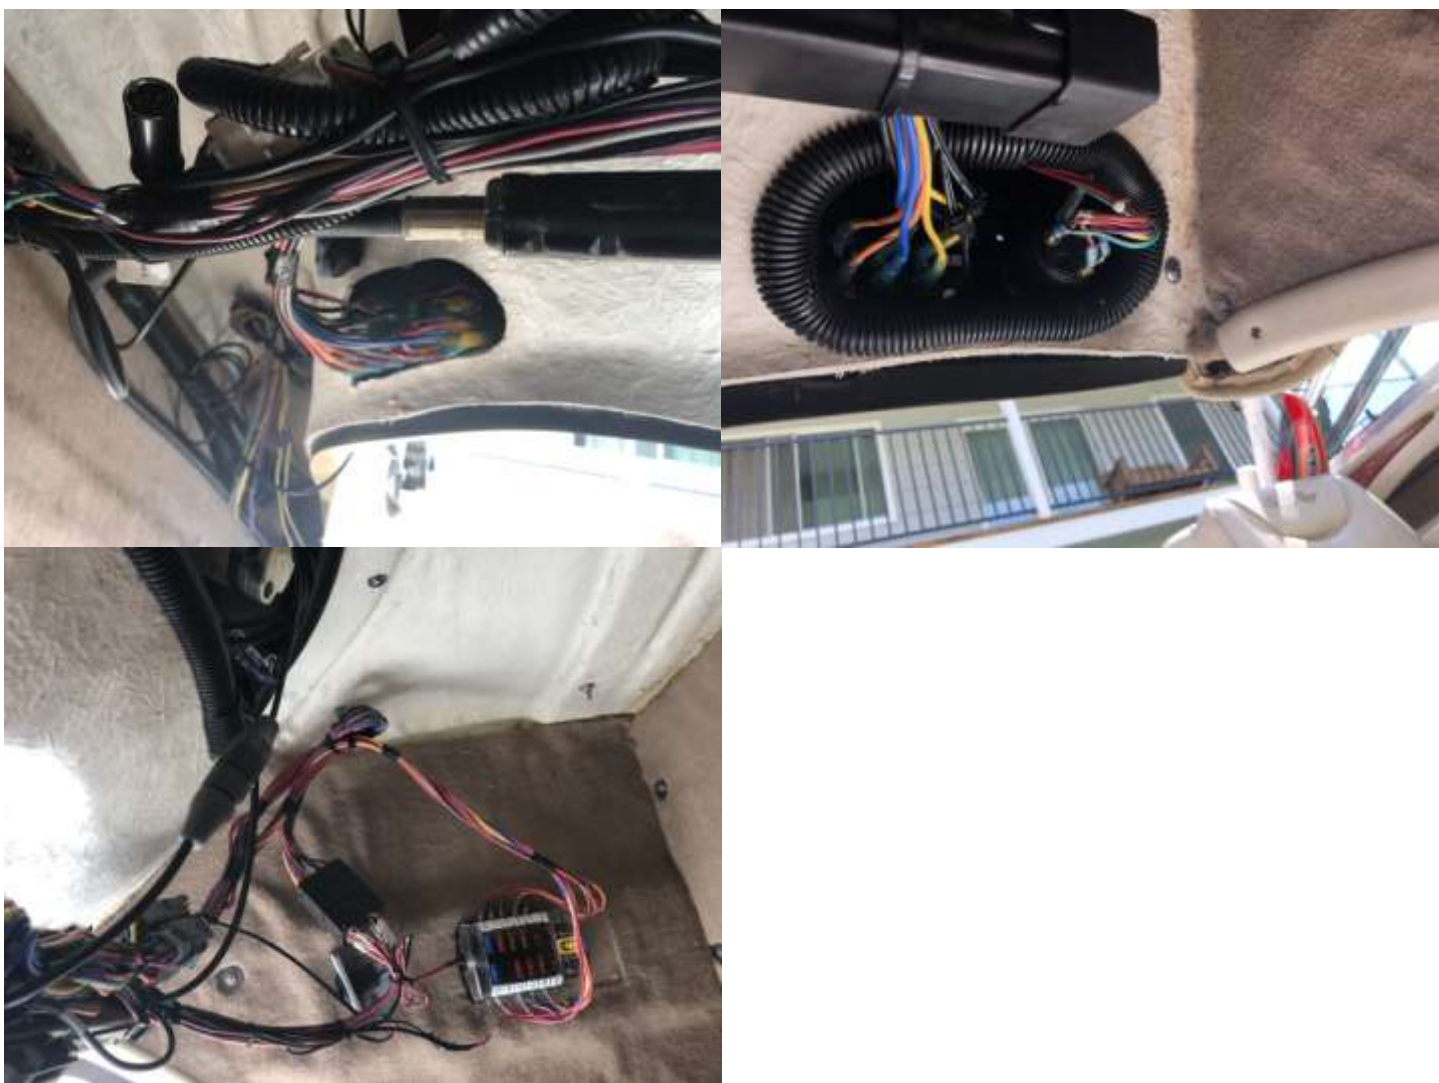
Figure 20: Routed all cables with existing wire bundles and secured with zip ties.

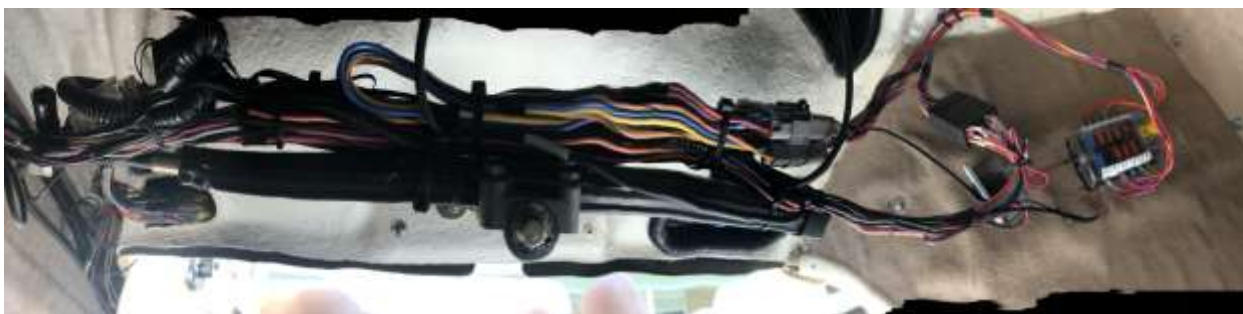
Figure 21: Panoramic of cable routing under helm.

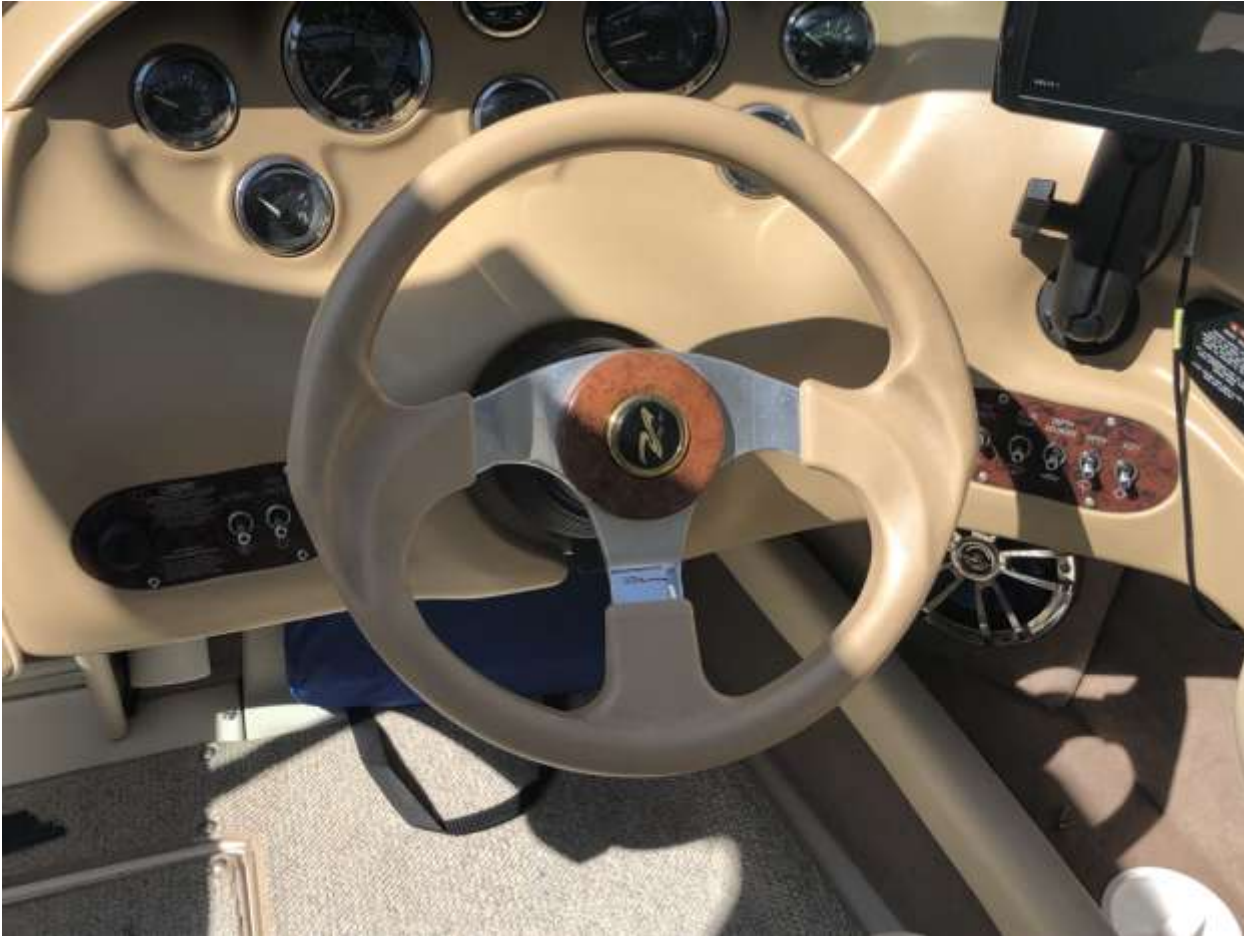
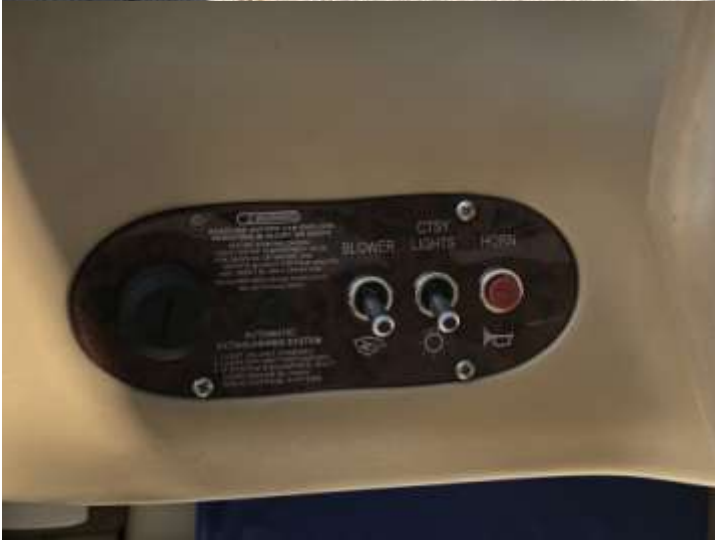
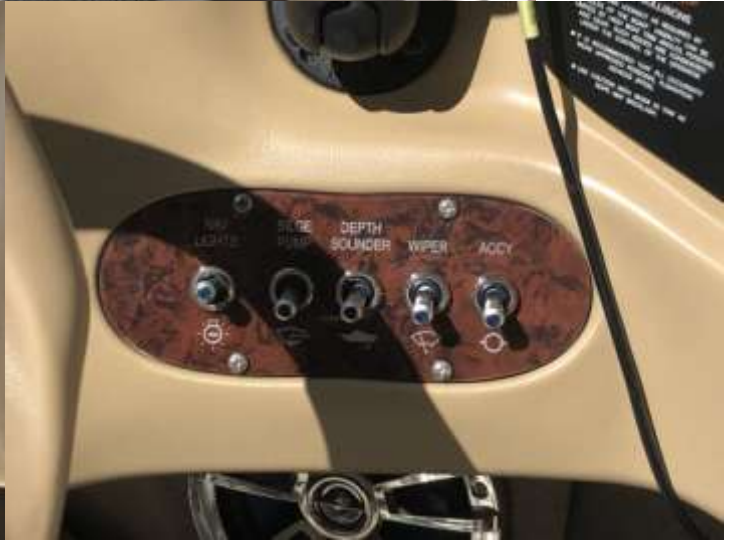
Figure 22: Finished! Note: There is a missing screw on the ignition panel. This is due to the original ignition switch cutout extending to far up. I will silicone in a screw so it looks complete.
