Re: Motor Vessel "Gritz" Claim (the "Vessel")
Claim No.: 20-1068426 (the "Claim")
DOL: October 23, 2020
Policy No.: 2748 (05/11) (the "Policy")

MARINE SURVEYOR - DAMAGE SURVEY REPORT

AT THE REQUEST OF: Brandon Fernald-vessel owner
VESSEL: 2001 34' Sea Ray Sundancer 340DA
"Gritz"
HIN#: SERT7505G001
DATE OF LOSS: October 23,2020

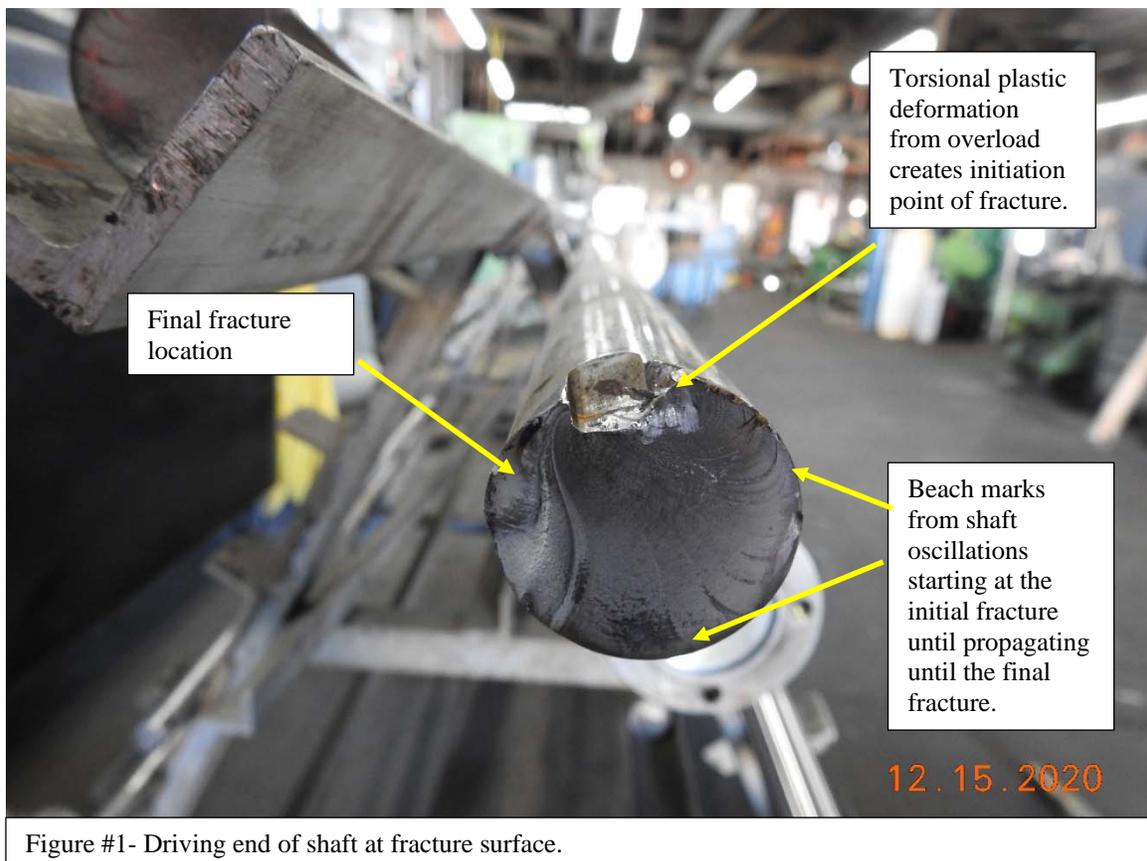
4. Following inspections of the vessel the undersigned attended the propeller shaft at Wilmington Ironworks. Inspections of the fracture surface of the propeller shaft revealed that there was plastic deformation on the outer surface of the shaft with a fracture initiation adjacent to the propeller keyway slot. Beachmarks consistent with the now oscillating, rotation of the shaft after the initial fracture, were observed across the fracture surface, terminating on the other side of the keyway with a sudden final fracture. No corrosion was visible on the fracture surface. The entire surface is similar in condition, consistent with a sudden fracture. See figure #1 below.

Damage to the propeller occurred while the propeller was turning at high RPMs and not from sliding back and impacting the rudder. Beach marks visible on the propeller shaft occurred after the initial break as the propeller shaft continued to rotate but because the shaft was compromised, and the propeller was out of balance, the shaft oscillated creating beach marks across the surface before the shaft completely failed. At 3,300 RPMs with the transmission gear ratio of 1.56:1 the propeller is spinning at 35 revolutions per second. On

the face of the broken shaft approximately 25 beach marks are visible. These beach marks were made in the less than one second from the time of the initial fracture until the shaft failed.

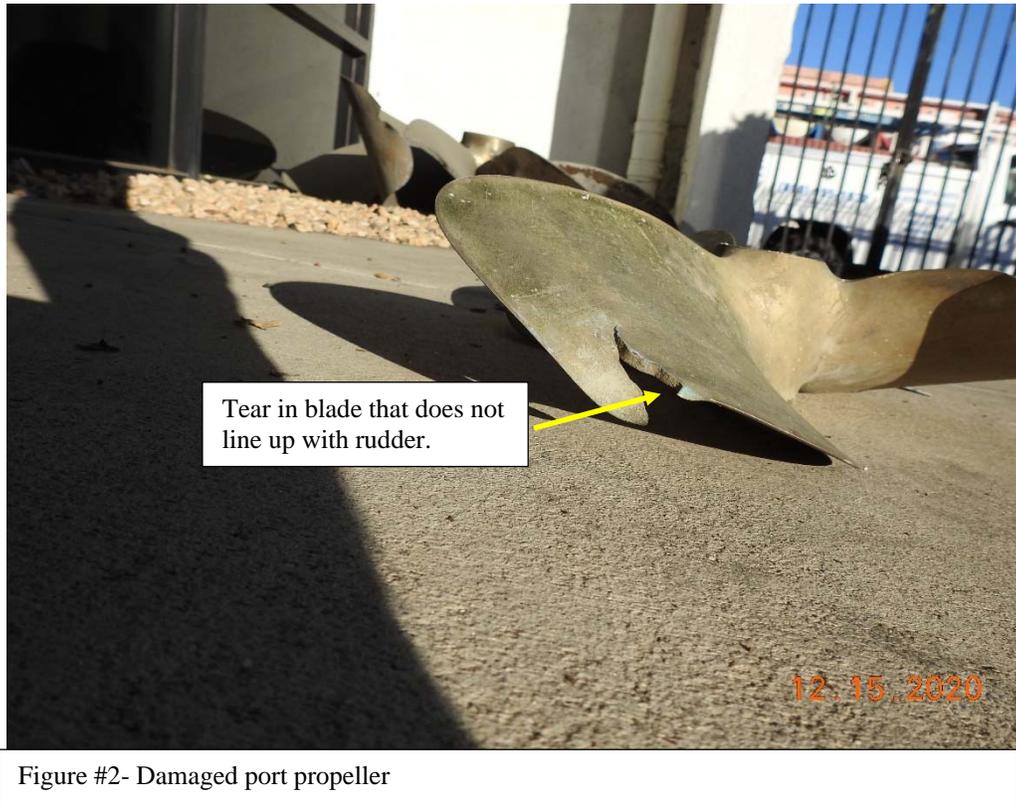
5. Inspection of the port propeller revealed impact damage consistent with striking an object. The damage does not align with the rudder and is severe so it could not have

occurred after the shaft broke and the propeller slide back to the rudder leading edge. See figure #2.

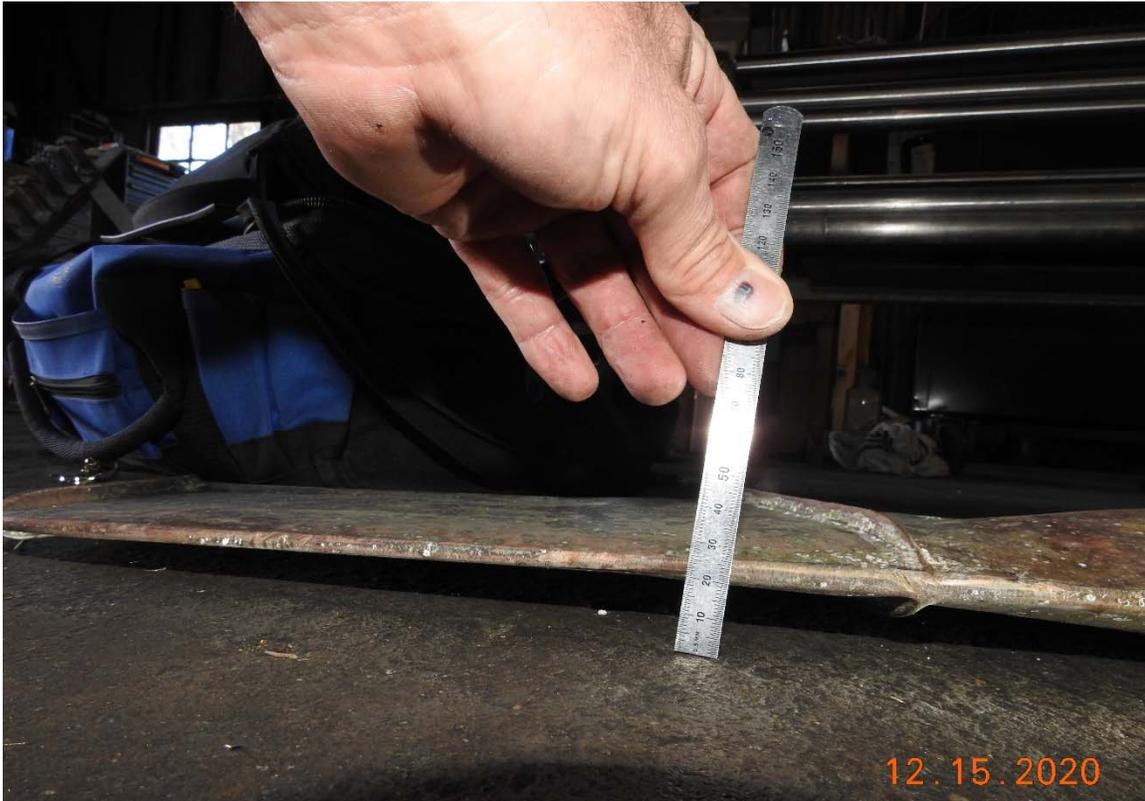
6. Inspections of the rudder leading edge did not reveal any impact damage. If the rudder had been impacted by the nibral propeller which is made of a harder alloy than the rudder, there would have been damage to the leading edge of the rudder and no damage from a substantial impact to the rudder leading edge was observed. See figure #3.

Figure #3- Leading edge of rudder where propeller impact would have been visible. If it caused the damage observed to the propeller.

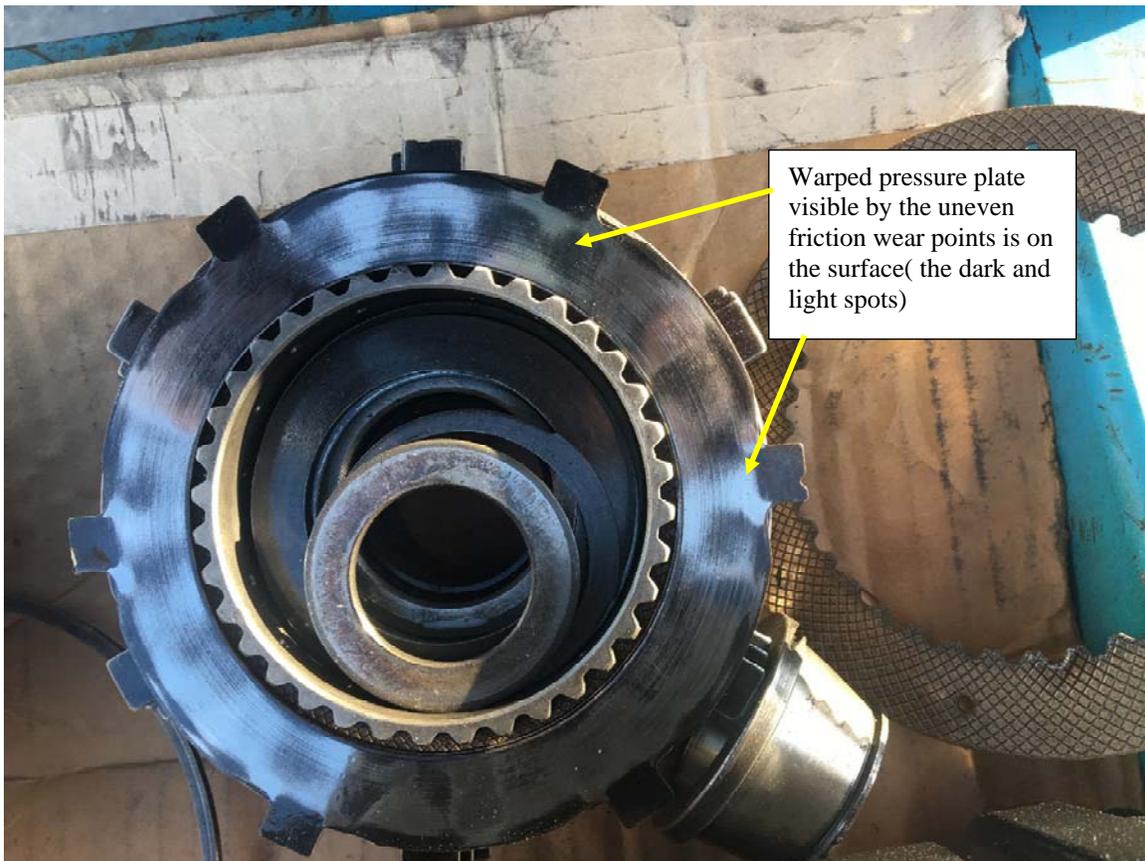
7. An impact with a submerged object that caused the observed damage to the propeller and to the propeller shaft would have created a torque overload of the transmission, as it appears that the propeller was suddenly stopped from turning at 3,300 RPMs, tearing one of the nibral propeller blades and fracturing the shaft. The undersigned has seen numerous transmissions damaged without a propeller shaft overload and fracture from striking of submerged objects, with the only evidence being a damage propeller. Inspections of the interior of the transmission revealed warped clutch pressure plates, which is consistent with a transmission overload. The warped pressure plates are what caused the assured to observed that the transmission would no longer go into neutral. Due to the extensive damage to the shaft and propeller re-using the present transmission without it undergoing complete disassembly and magna flux inspections to ensure there are no micro cracks in

the gears and shafts would be well outside industry norms. The cost of the disassembly and magna fluxing, along with the cost of replacing the already visibly him damaged clutch components would exceed the cost of a replacement transmission. It is opinion of the undersigned that the vessel owner's decision to replace the transmission rather than to repair it was prudent and was the most cost-effective repair. Damages to the transmission pressure plates can be seen in the figure #4.

Figure #4- Warped clutch pressure plate.

Based on telescoping damage theory, it is known that the damage occurred first at the propeller, then the shaft, then the transmission. At this stage the vessel owner does not believe there is any damage to the port main engine. The damage to the transmission is readily visible in the form of warped clutch pressure plates. The plates become warped when they received a high load at the shaft when they are trying to transfer full horsepower through the clutch to the shaft. Further investigations into the transmission condition would be costly and based on the low price that the vessel owner was able to purchase the replacement transmission at, it appears he made a prudent decision.
