COMPANY #: 20-1068426
INSURED: Fernald, Brandon
DATE OF LOSS: 10-23-20
HCSS FILE #: 213156-20

FIRST REPORT

The vessel was described as a 2001 Sea Ray 340 Sundancer bearing Hull Identification Number (HIN) US-SERT705G001. Policy information was not provided with the assignment.

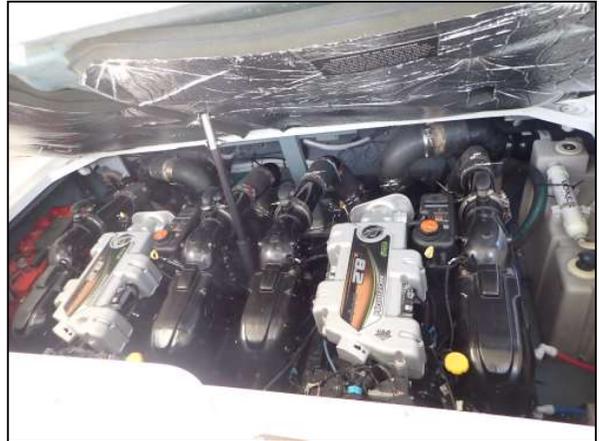
Engines have been renewed with 2019 MerCruiser 8.2 Horizon V-Drive gasoline engines.

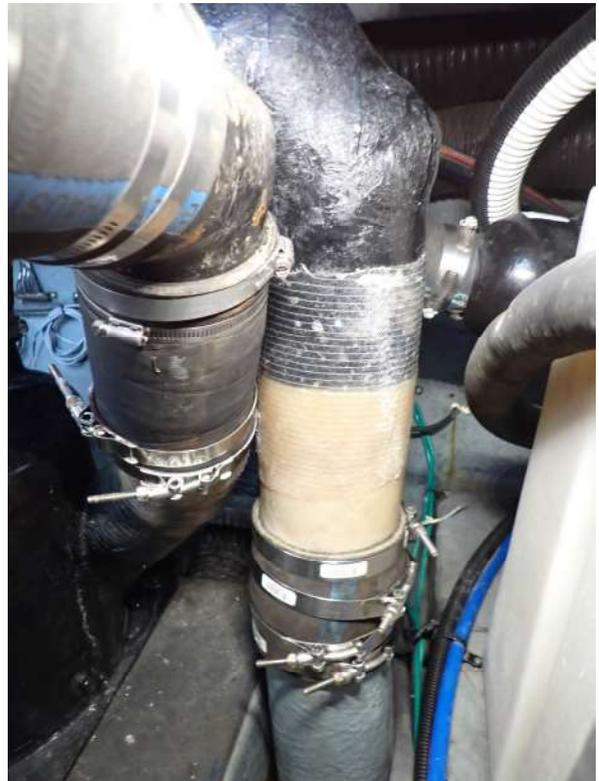
Modifications to engine exhaust systems do not appear to meet standards. An extension of proper design has been fibreglassed in place with single layer of glass and resin. Clamps are not properly installed

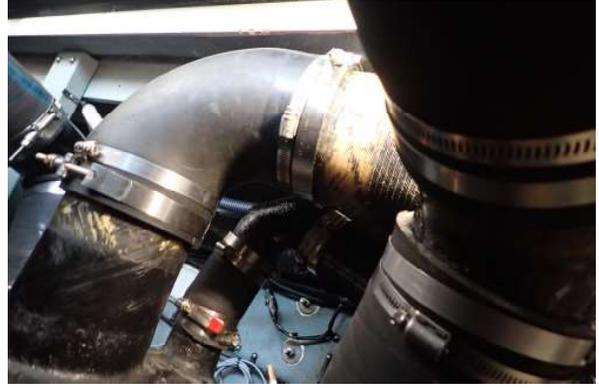
Exhaust hoses do not appear to be fully seated on muffler and improperly sized clamps installed.

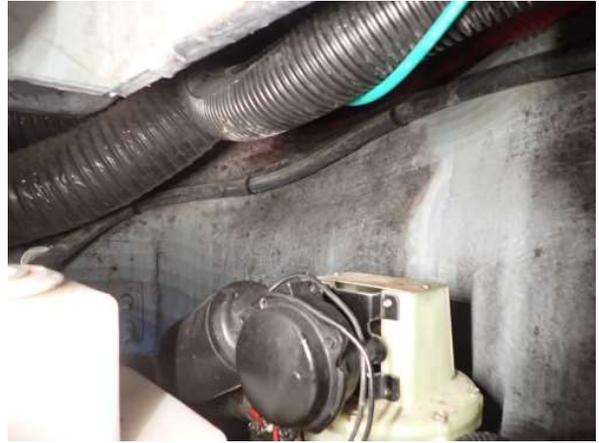
Aft port side interior of engine space exhibits evidence of historical leaking fuel from above. Suspected fuel fill leak – a well known condition on this model of vessel.

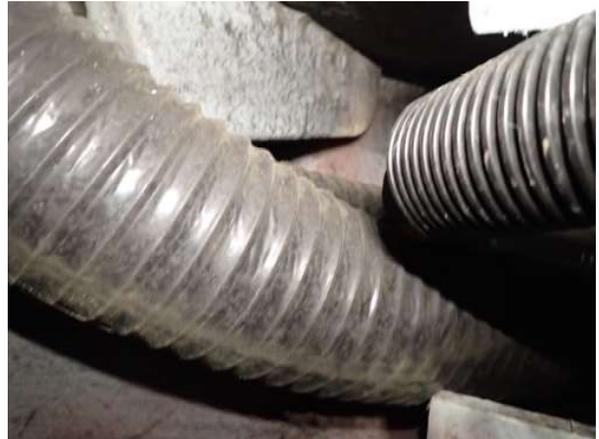
Suspected fuel leaking down bilge blower ducting from above.

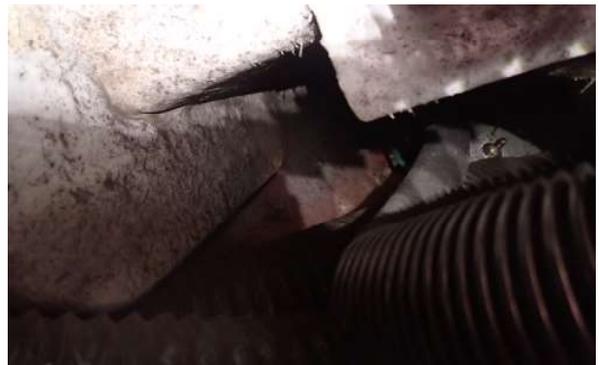
Port side fuel hose appears to have staining from external leaks. Additional examination if highly recommended.

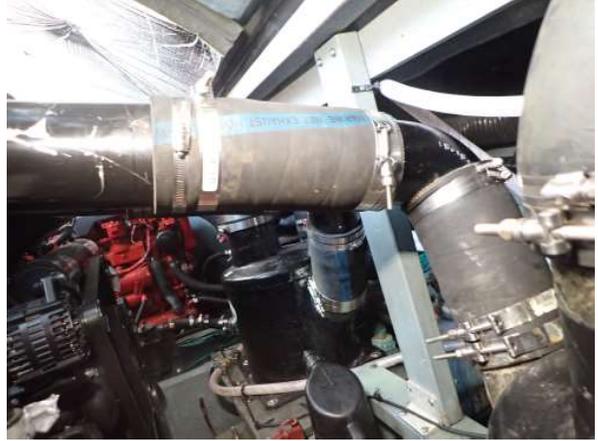
Improperly installed exhaust hoses and clamps. Carbon Monoxide exposure hazards.

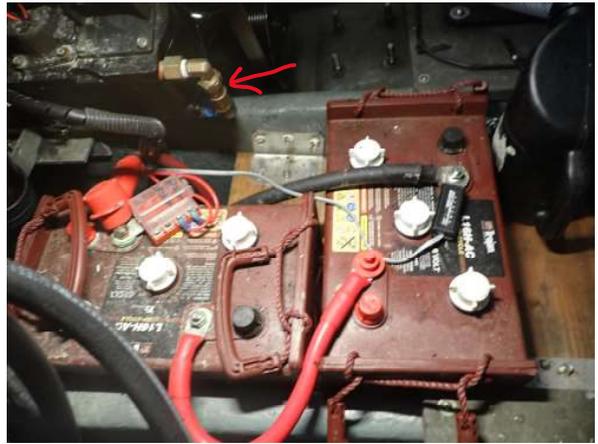
Batteries are installed between stringers without boxes or covers. Batteries are installed directly under starboard engine fuel system in violation of 12 inch umbrella – preventing of off-gassing during charge.

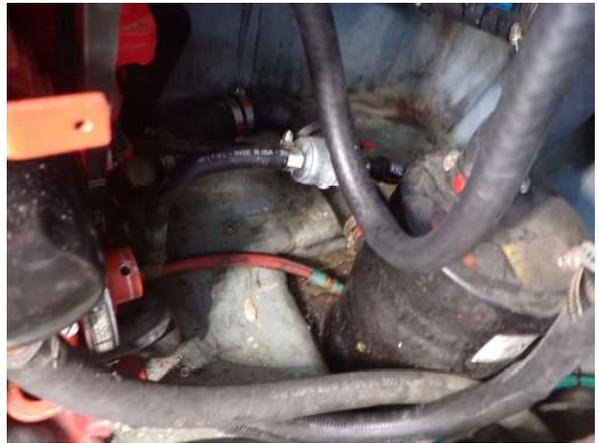
In-line fuel filter installed to supply hose of generator is not rated for installation in gas engine space.

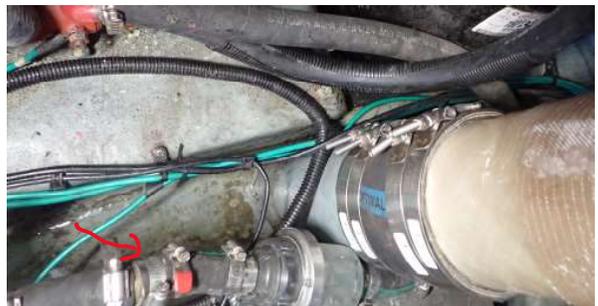
Water hose is cut by improper installation of hose clamps creating potential & significant point of water ingress.

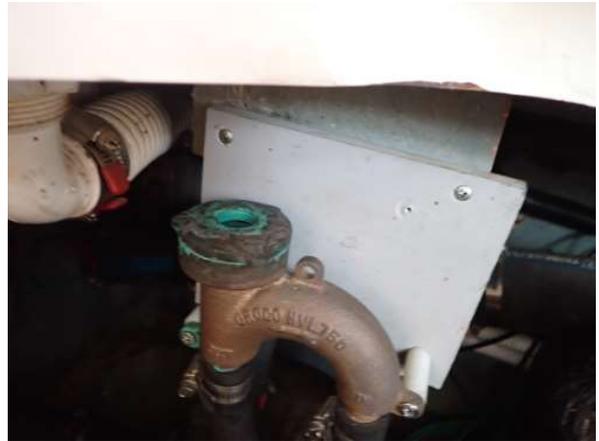
Generator siphon break appears to be leaking can allow water reversion to generator.

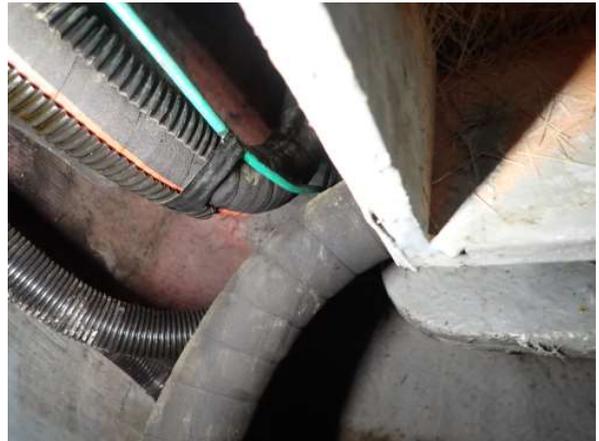
Starboard fuel fill hose appears to be staining from above.

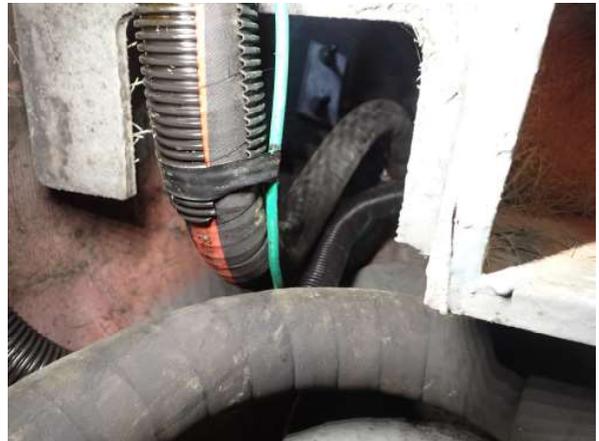
Starboard fuel fill hose appears to be leaking (not actively present) during fueling. Staining of the hose exterior and hoses below it suggest significant leaking of fuel. Hose should be immediately inspected for condition as it an explosion hazard.

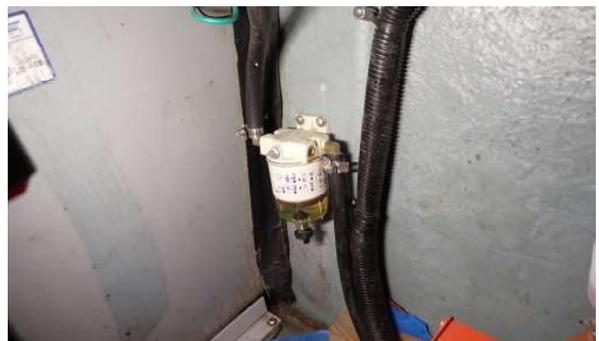
Fuel filter installed in engine space not permitted for gasoline engine compartment.

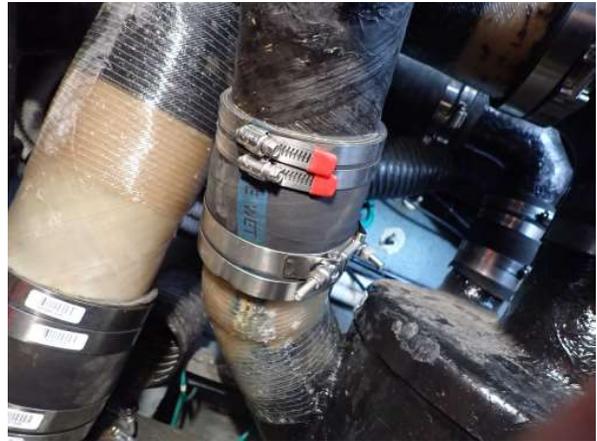
Modifications to exhaust components.

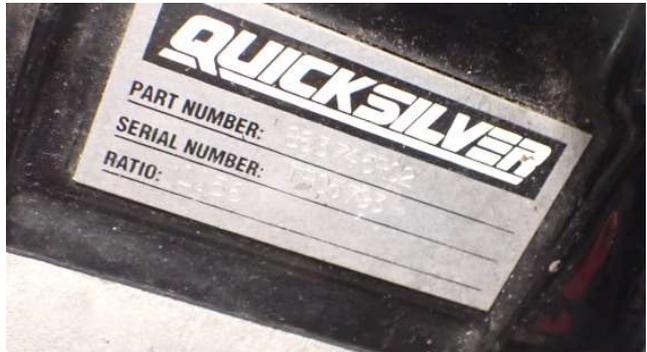
Transmission Part and Serial number designation plate.

The starboard transmission appears to be OEM to the vessel by model, but is a remanufactured assembly by MerCruiser Marine Remanufacturing. Part number 663745R02 designates a ZF Hurth 630-V V-drive transmission with a 1.5 gear ratio. This gear ratio is no longer used, in consideration of the 2019 model year engines. MerCruiser information indicates use approximately 1996 to 2002, accurate to the year model of the vessel.

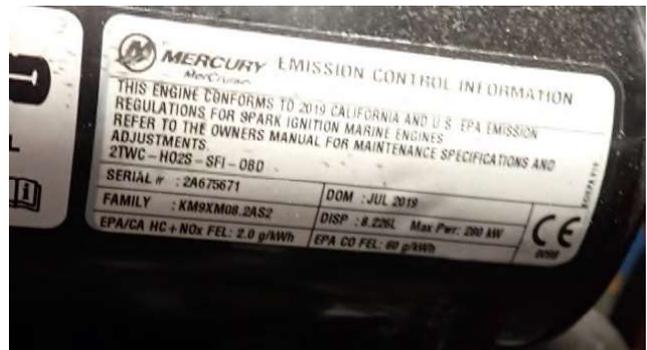
Engine Serial and model information affixed to one of the engines indicates manufacture date of July 2019 serial 2A675671.

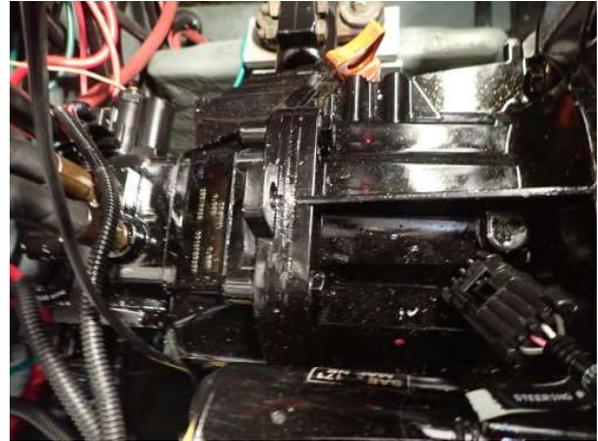
Replaced port side V-Drive Transmission.

The reportedly replaced port side transmission also appears to be a remanufactured assembly of a 1.560 / 1.567 gear ratio. A manufacturer is not immediately identifiable.

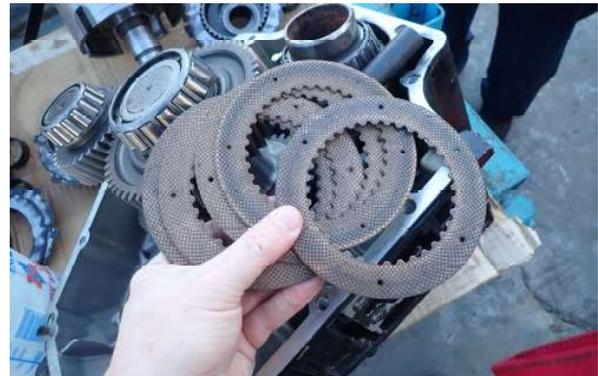
The original transmission and propeller shaft were located at CC Marine also of Marina Del Ray. Inspection of those components was completed the following morning. The repairer's technician "Manny" accompanied and directed me to the components. The transmission was observed in a disassembled state. Transmission plates were the first presented with all the plates revealing high temperature discoloration. The plates were scored and warped due to excessive heat. The brass plates were worn severely with little surface profile remaining. Of the 11 plates, 6 were deformed and cupped consistent with excessive heat. No brass peeling or crushing was present.

Clutch plates exhibit slipping and worn plate surfaces. Plates show irregular surface contact with deformation inducing the irregular contact. Heat produced by uneven contact.

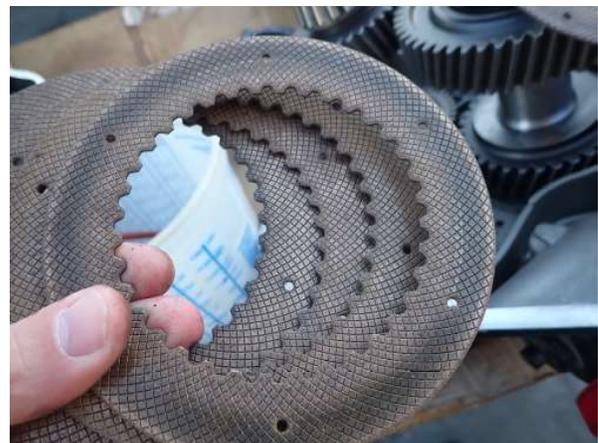
Heat discoloration of plates.

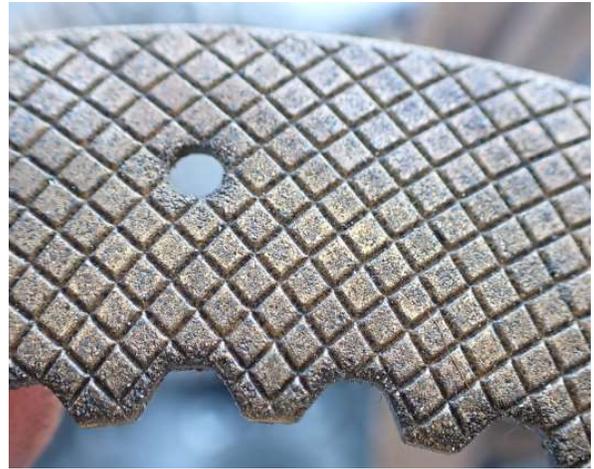
Plate surface topography exhibits overheating and cavitation around circulation port. Uneven surface wear evident.

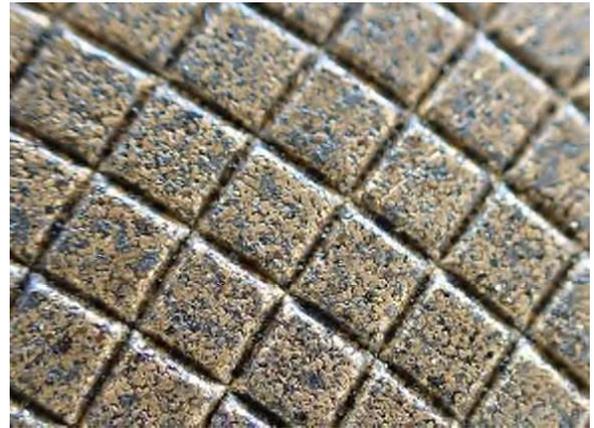
Surface topography of clutch plates exhibit slipping and uneven wear.

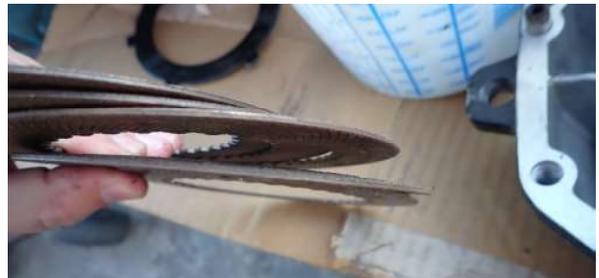
Clutch plates are deformed from excessive heat.

The transmission inspection failed to reveal any evidence of overload to any of the gears, bearings or splines. Instead, heat development in the plates was present along with heat-based warping of the both the steel and brass plates. Not a single aspect of this type of damage is consistent with a single event of overload.

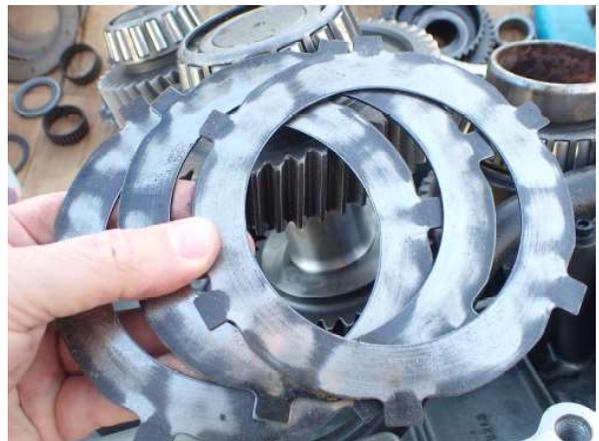
Clutch plate steels exhibit extensive slipping and heat discoloration.

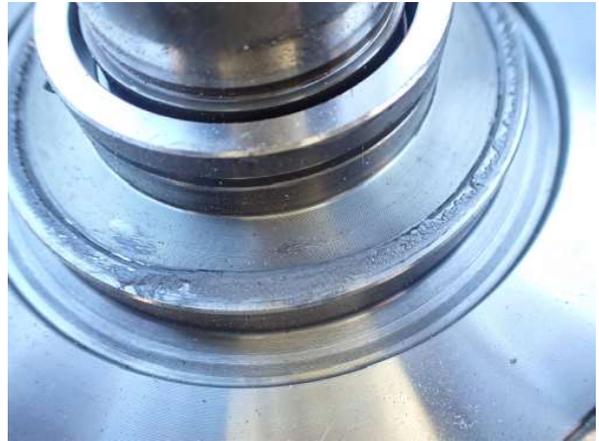
Metal residue throughout transmission components.

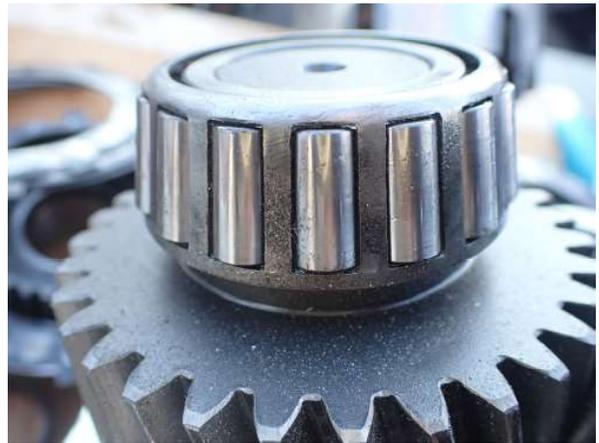
Transmission tapered bearings and rollers all appear in good condition. No bluing, heat, scoring, or misalignment evident.

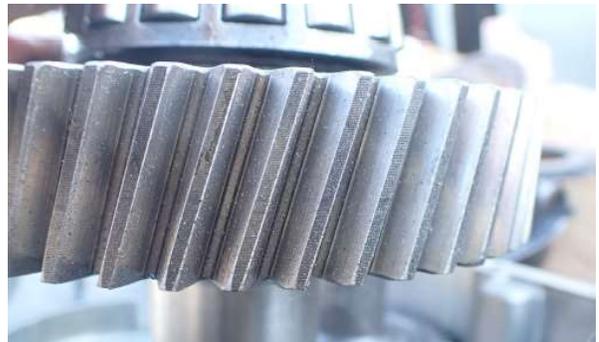
Gear teeth of transmission all in good condition with no evidence of overload. Normal alignment evident. Plate metal is circulated on all components.

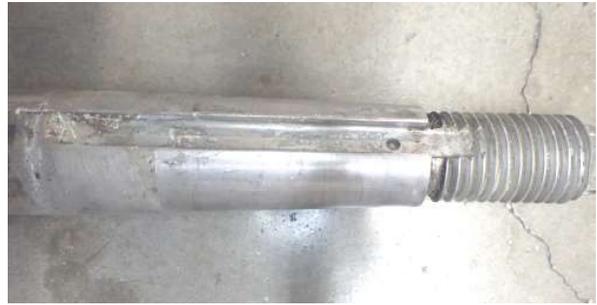
The propeller shaft was reported to have sustained a catastrophic overload from allision as evident by a fracture supposedly originating at the propeller keyway. The propeller was not presented for inspection. However, upon being presented the propeller shaft, it was immediately noted the shaft fracture originated at the transmission coupling end of the keyway, not the propeller end. I made inspection of the propeller end of the shaft first noting no evidence of keyway impingement. The key was not present.

Propeller end taper and keyway of propeller shaft. Evidence of poor propeller fit but no evidence of overload present.

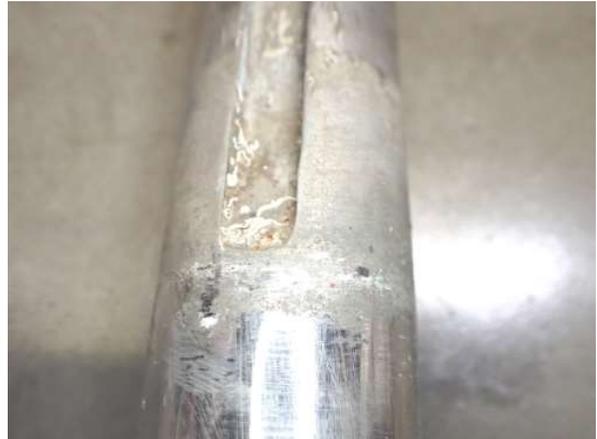
Propeller end keyway at taper exhibits no fractures. The loose propeller has produced minor rounding of the keyway shoulder. No overload damage present.

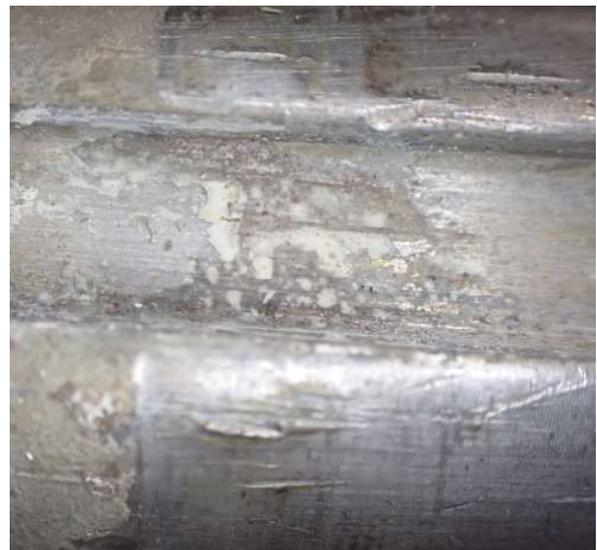
Keyway floor shows of slipping key. Rounding of the shoulder demonstrates the key was rolling over the shoulder resulting in its long-term deformation.

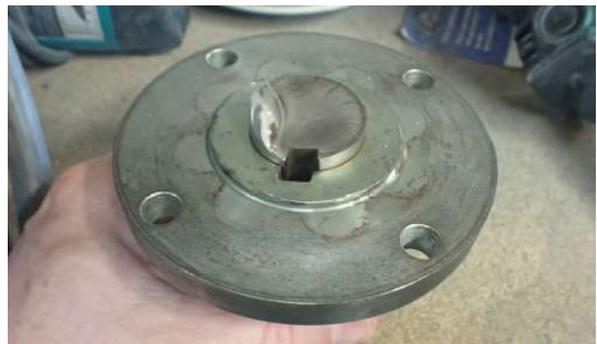
Propeller shaft coupler and propeller shaft end as presented. Metal fatigue is demonstrated in topography of the fracture surface.

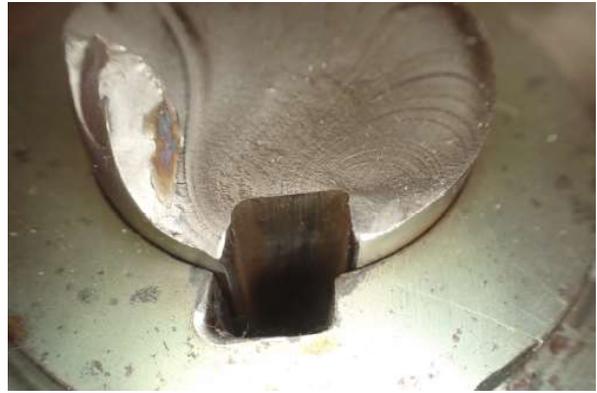
Propeller shaft end and coupler at keyway reveals deformation of the shaft end keyway in both directions.

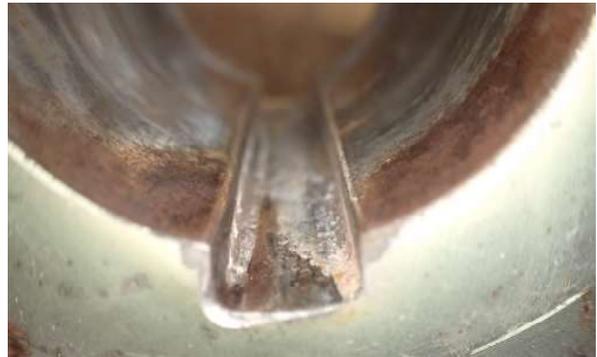
Keyway cut and internal taper of coupling shows loose fit and apparent coupling and shaft misalignment.

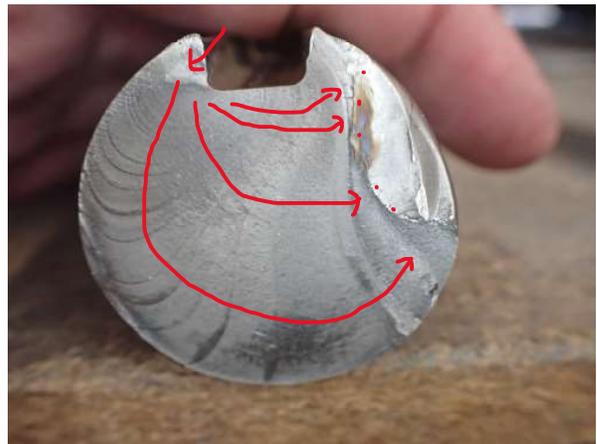
Fracture topography in propeller shaft reveals origin / incipience of the fracture propagation at the left side of the keyway. Over time, the fracture has propagated to the area of final failure at the right side of the fracture where the last 10% approx. of the shaft remained.

Initial information you provided detailed a failure to the propeller shaft and transmission were reportedly the result of an allision or some form of overload failure. However, the inspection of the propeller shaft found the fracture to have originated at the forward end at the transmission coupling, not the propeller end. In consideration of a propeller shaft, the material is ductile and has an inherent elastic and plastic limit over its length. Hence, the input force from an allision or overload would be greater at the propeller end of the keyway as opposed to the coupling end. Fatigue failure in metals may or may not have an initial stress due to the presence of stress risers, notches, or inclusions no longer being evident. Fatigue is generated by the alternating plastic strain in amplitude to propagate the small micro-cracks in the surface.

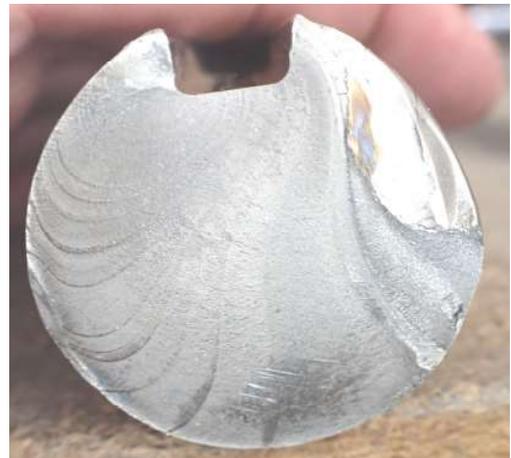
Fatigue propagation overly apparent in fracture topography.

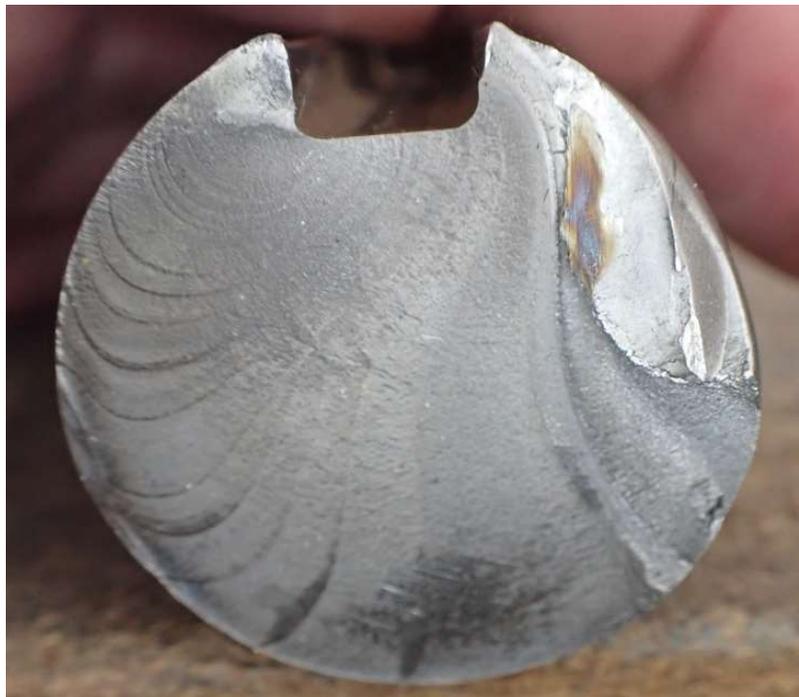
The photograph of the presented shaft fracture topography clearly demonstrates all phases of the fatigue process.
