## **Water Leak Diagnosis For Leaks at or Below Waterline**

Areas to inspect when external water is found inside the hull or stringers, both static and when running

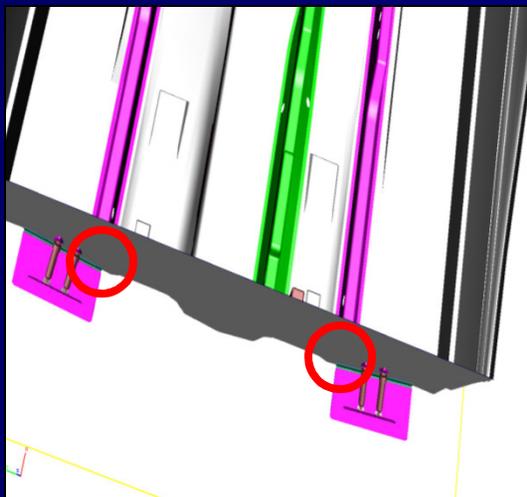
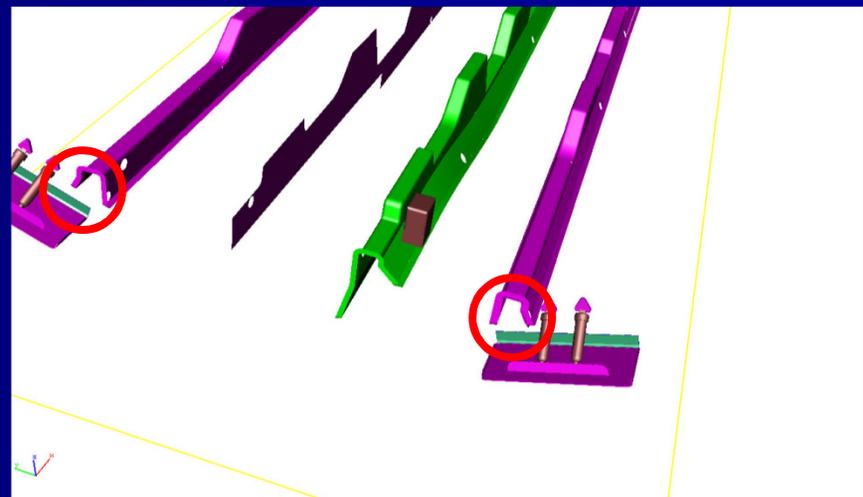
- Leaking trim tab mounting screws where inboard mounting screws can often penetrate into the stringer cavity

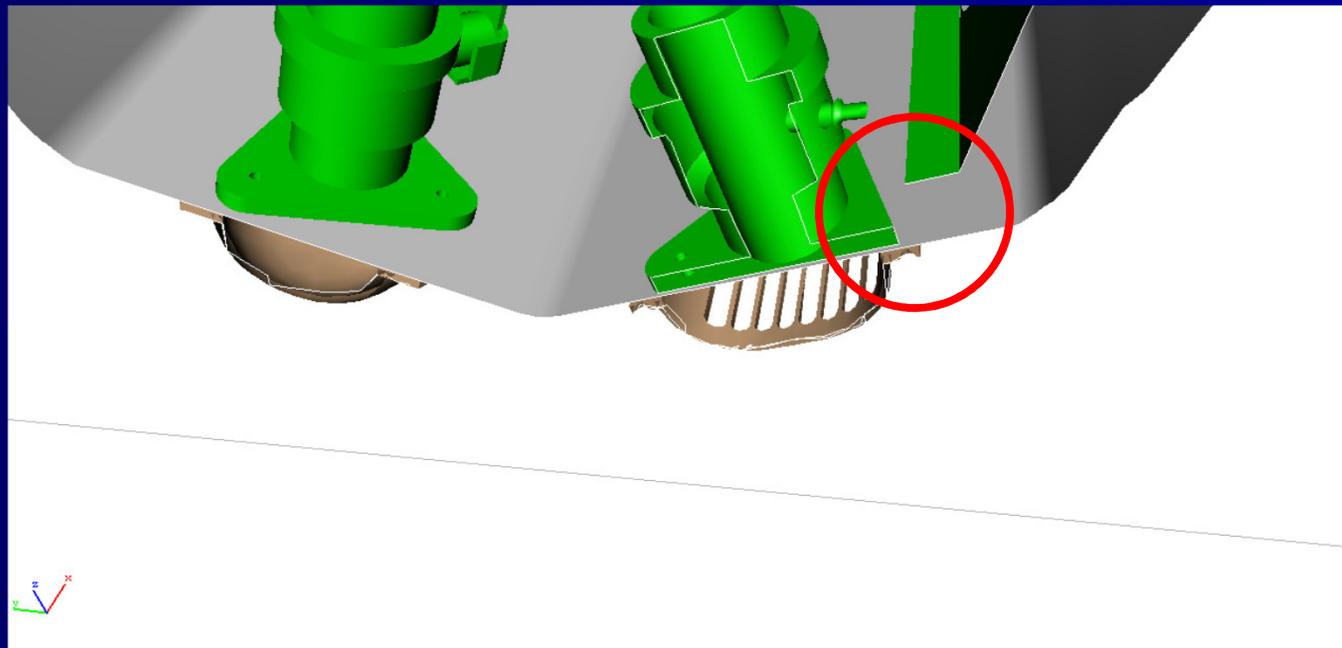
- Leaks around thru hull or seacock locations where stringer overlaps hull penetration area, any void can force water around thru hull, under stringer tabbing into stringer cavity

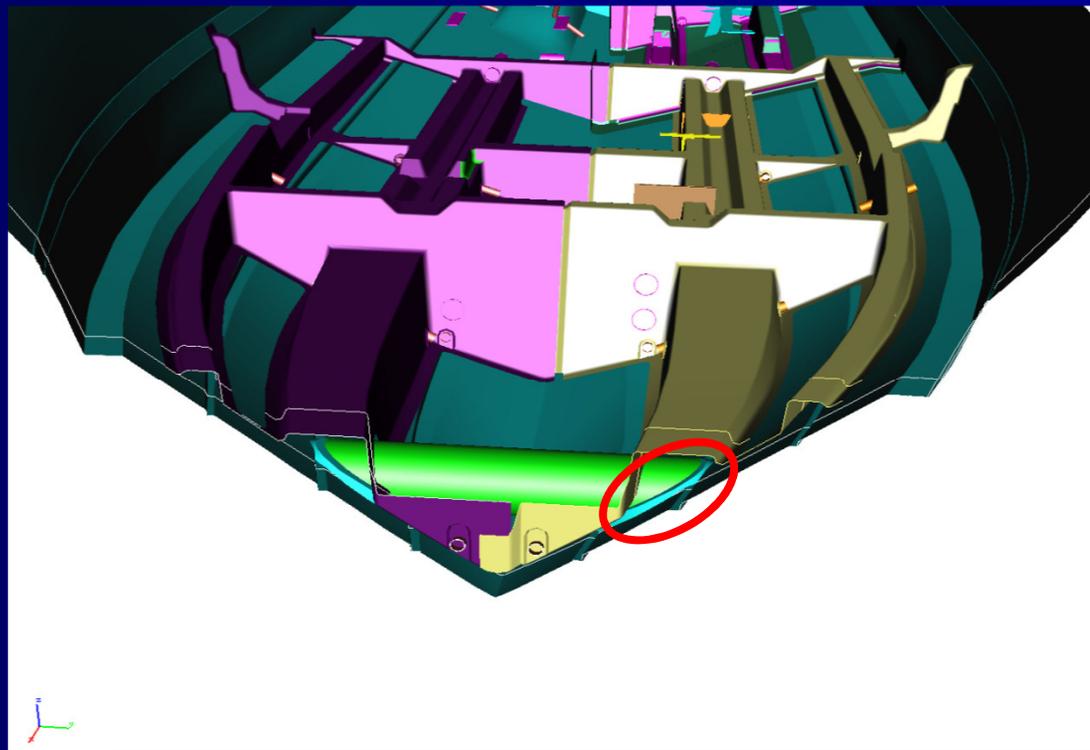
- Voids or cracks around bow thruster tube can seep into stringer cavity where tube and stringer overlap

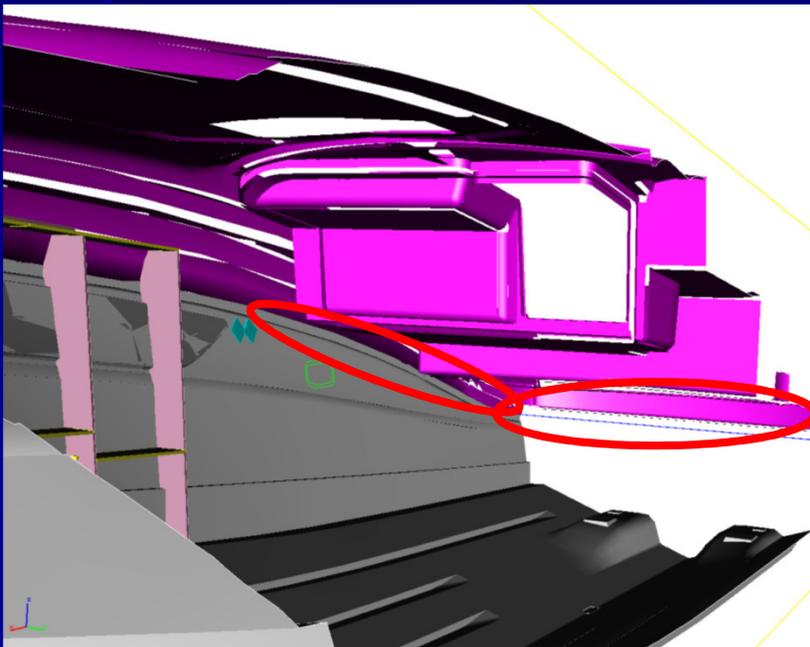
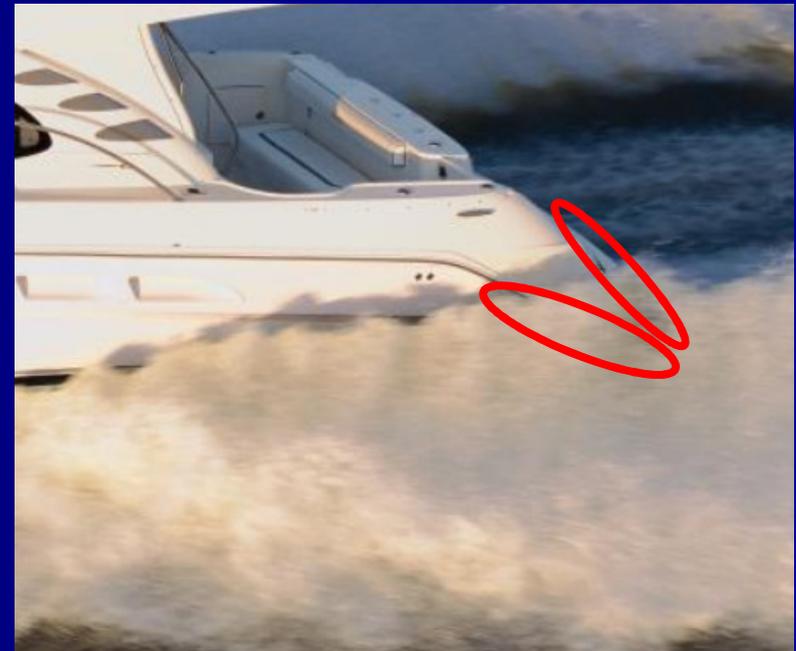
## Water Found In Bilge-Engine Room-Transom, often found after running but not while sitting static

- Often times high water pressure while running can force water in at the rubrail where it wraps around the hull side at the transom. As it is above the static waterline, this leak often only happens while at various running angles where rubrail may be at, or under waterline.
