No. 97-20

Official Notification Under The U.S. Federal Boat Safety Act

EFI and MPI Fuel Line Replacement

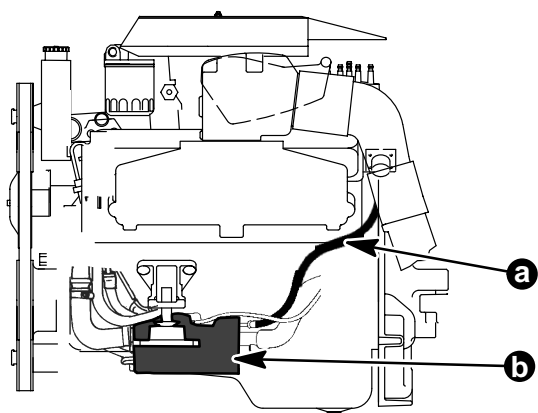
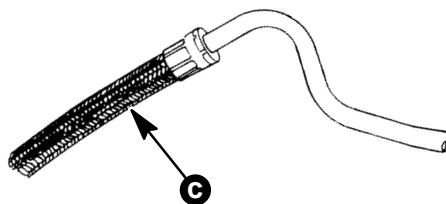
1. MCM 4.3L EFI, 5.0L EFI, 5.7L EFI (TBI) Sterndrive Engines:

Look at the fuel cooler to TBI fuel line. If it is braided, the fuel line IS GOOD and does not have to be replaced.

- a - Fuel Line to TBI
- b - Fuel Cooler.
- c - Braided Fuel Line.

Change incorrect fuel lines on any engine that you have in stock. If the boat has been sold, please contact your customer and perform this service on their engine(s).

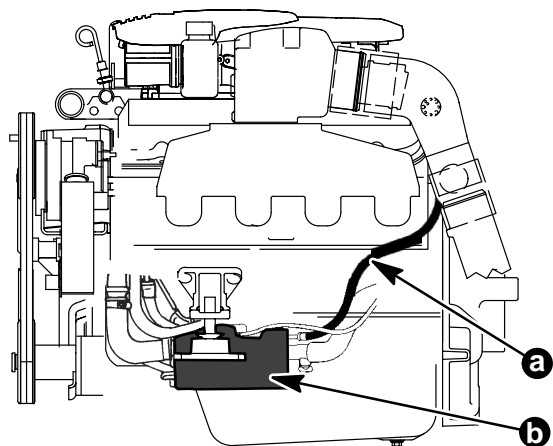
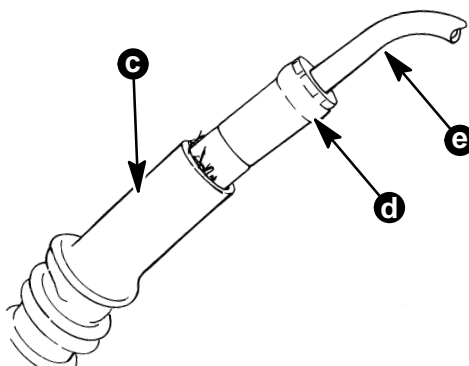
2. 1997 MCM 7.4LX MPI, 454 Mag MPI, 502 Mag MPI Sterndrive Engines:

Look at the fuel cooler to fuel rail line. If the fuel line has a 'fire sleeve' AND the metal hose coupler is brass, the fuel line IS GOOD and does not have to be replaced.

- a - Fuel Line to Fuel Rail.
- b - Fuel Cooler.
- c - 'Fire Sleeve' Pulled Back.
- d - Brass Hose Coupler.
- e - Stainless Steel.

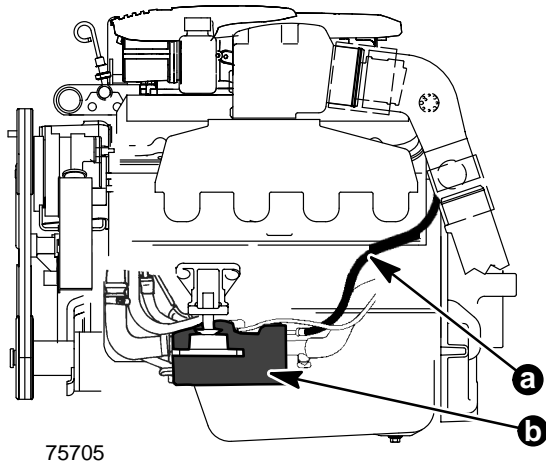
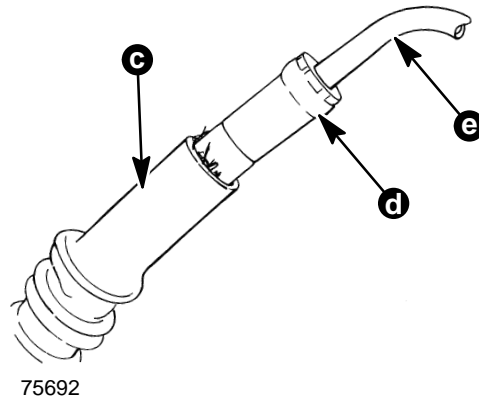
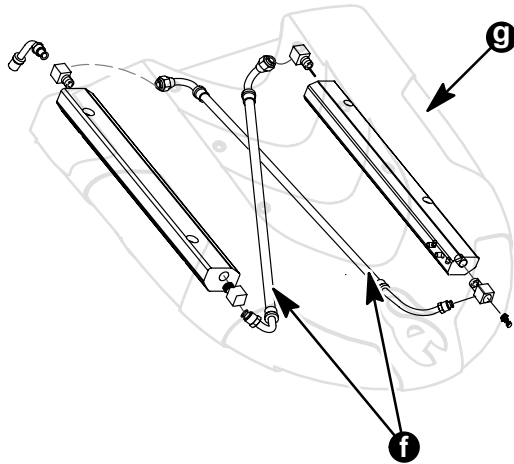
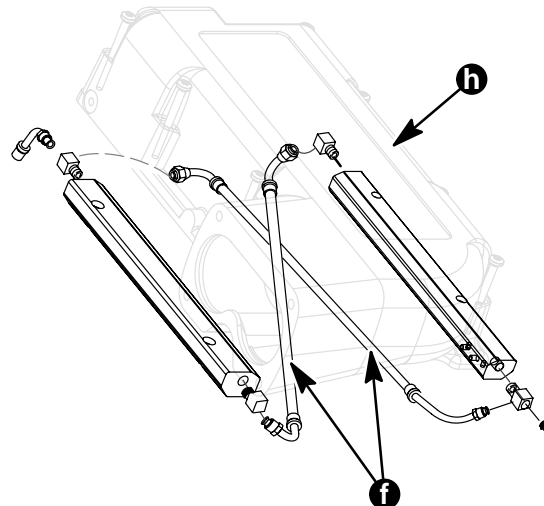
3. 1997 MCM 350 Mag MPI Sterndrive Engines:
 1997 MIE Black Scorpion MPI Ski, 377 Scorpion MPI Ski Engines:
 1998 MCM 350 Mag MPI Sterndrive Engines:
 1998 MIE 350 Mag MPI Ski Engines:
 1998 MIE 350 Mag MPI Inboard Engines:

- a. Look at the fuel cooler to fuel rail line. If the fuel line has a 'fire sleeve' AND the metal hose coupler is brass, the fuel line IS GOOD and does not have to be replaced.
- b. Also look at the 2 rail to rail fuel lines. If the fuel lines have a 'fire sleeve' AND the metal hose couplers are brass, the fuel lines ARE GOOD and do not have to be replaced.

- a - Fuel Line to Fuel Rail.
- b - Fuel Cooler.
- c - 'Fire Sleeve' Pulled Back.
- d - Brass Hose Coupler.
- e - Stainless Steel.
- f - Rail to Rail Fuel Lines.
- g - Scorpion Intake Plenum.
- h - 1997 350 Mag MPI Plenum. Not On 1998 350 Mag MPI Engines.

NOTE: Use a small amount of liquid soap on 'O' Rings to ease installation.
